SAFETY ALERT

FATALITY

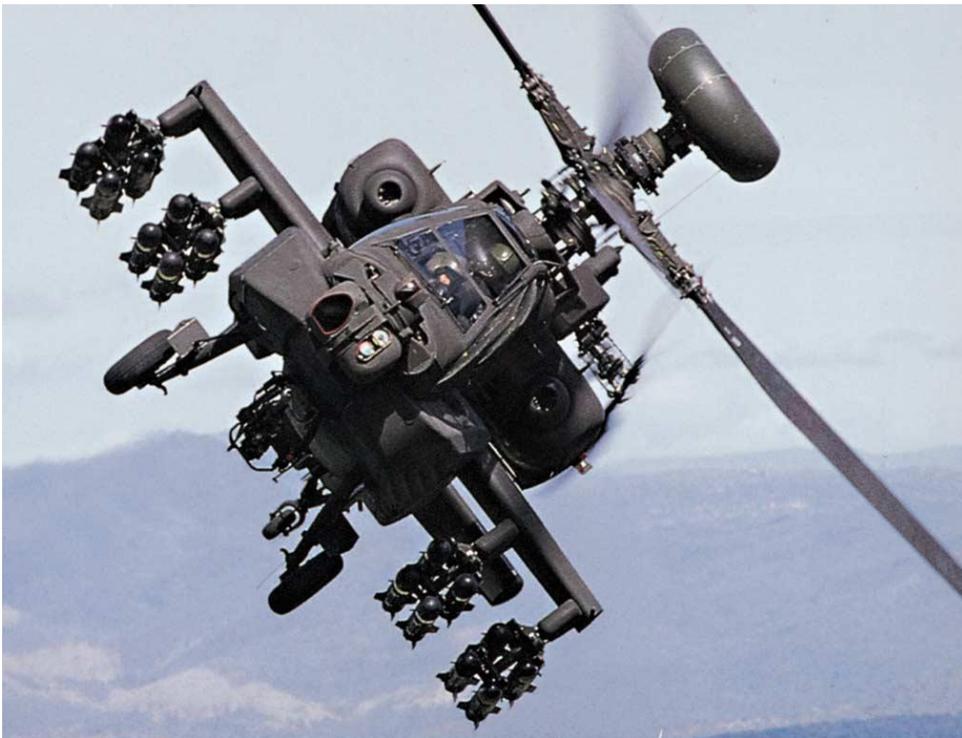
While conducting a day reconnaissance mission in mountainous terrain, an AH64 crew performed a decelerating left turn at low altitude, experienced low rotor RPM, and descended into the ground. This accident resulted in one fatality, one serious injury, and a total aircraft loss.

- Always calculate, brief, and verify aircraft performance capabilities
- Crews should discuss contingencies and emergencies, such as when to jettison external stores
- Utilize good crew coordination; direct/offer assistance
- Remember the two challenge rule always requires time to react
