MRAP Gunners Hatch Safety OIF SB-028

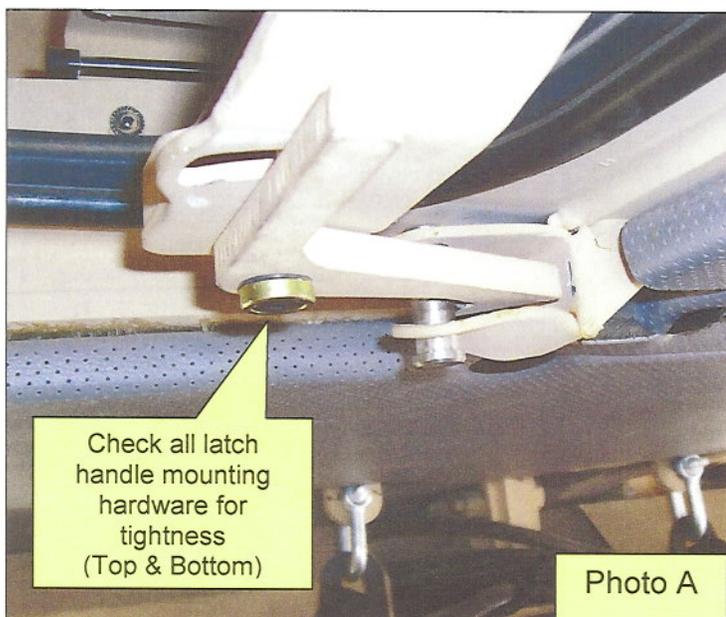
Gunners hatch latching handle hardware falling out

Loose Hardware from vibration

Inspect all hardware in the latch handle assembly (Photo A). This includes the screw and nut that run through the center of the handle. Inspect the pin that the handle latches to for wear. Ensure that the snap ring (Photo B) that holds the pin in the bracket is serviceable & firmly seated in the groove of the pin.

Inspect hardware on all handles and latching mechanisms to ensure tightness. Tighten hardware as necessary before and after operations.

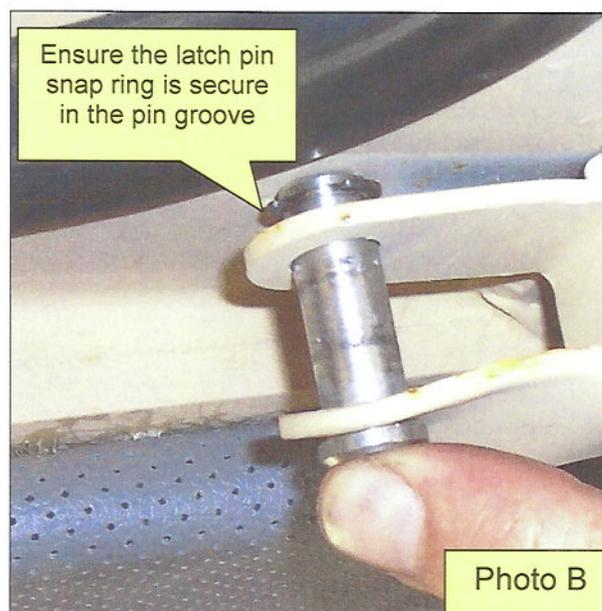
A snap ring on the pin the locking handle latches to came off (Photo B), which caused the pin to fall out. A spring then popped off the latch handle and due to vehicle momentum on a decline, the armored hatch slid forward and struck the Soldier in the legs. He suffered painful crushing injuries to both legs that resulted in two days lost time (quarters) and seven days of restricted duty.
