ARMY GROUND RISK-MANAGEMENT PUBLICATION

VOL 22 NO 2

FEBRUARY 2001

SPECIAL NIGHT-VISION ISSUE

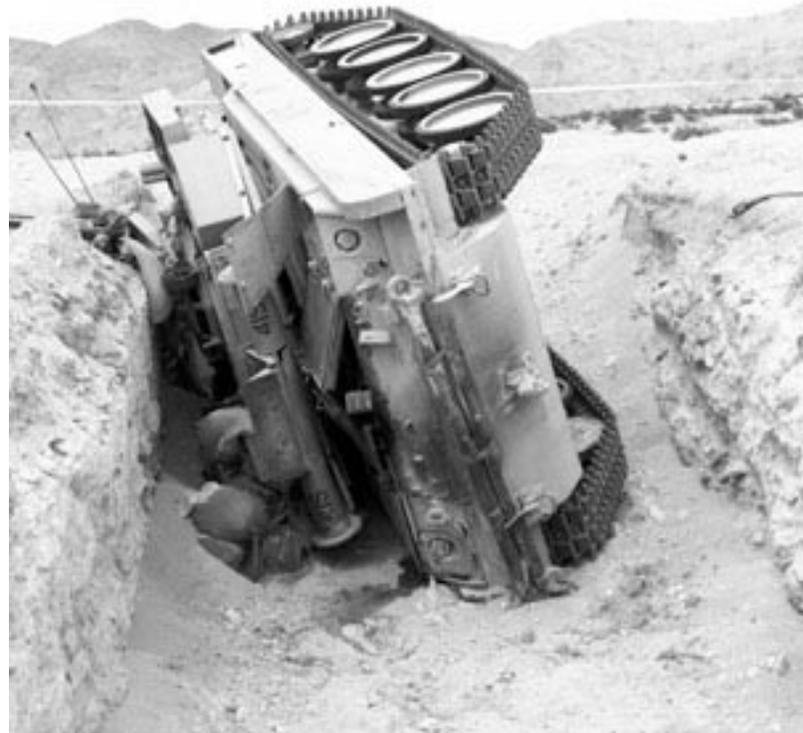
Consequently, the driver unintentionally drove into their fighting position, resulting in the tank rolling over. Tragically, 2LT Jones was standing in the hatch above nametag defilade and was fatally injured.

■ 2LT Jones was specifically told to wait until first light to continue efforts to locate the designated BP; however, he made an improper decision to continue searching after darkness.

however, by having exaggerated confidence in his crew's ability to locate the BP using NVDs, he deviated from the order to halt his movement until daylight.

■ He did not utilize available equipment such as the lensatic compass, map, or his GPS Receiver, which were all serviceable.

■ He should have been in the nametag defilade position.

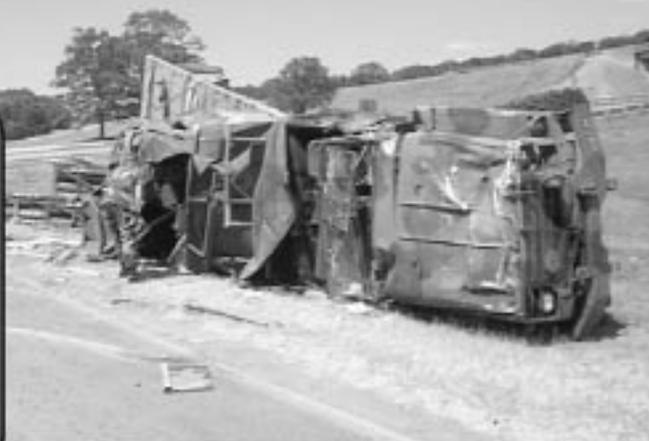
tires were blown on the second axle of the tractor.

- Overloaded trailer
- Overconfident & inattention
- Unclear standards
- Leadership failure

- 2 Injuries
- \$450,000 cost plus truck & trailer damage

driver and the senior occupant were removed from the truck. Luckily, both soldiers survived this accident; however over \$1 million in property was damaged!

- Train leaders in system limitations
- Train drivers & senior occupants on responsibilities
- Clarify load configuration guidance
- Risk management education

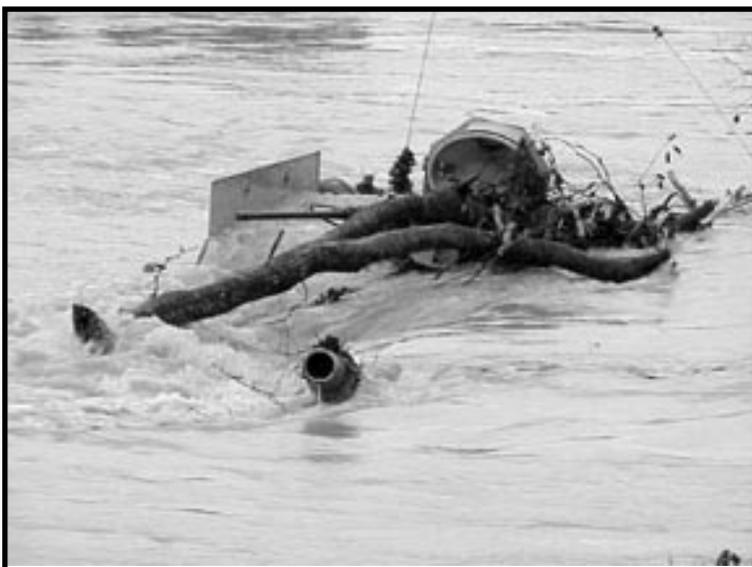
Can You Identify This Vehicle?

Stay tuned, there's more to follow next month regarding this accident.
