Flightfax

ARMY AVIATION
RISK-MANAGEMENT
INFORMATION

APRIL 1997 ♦ VOL 25 ♦ NO 7

Spatial Disorientation

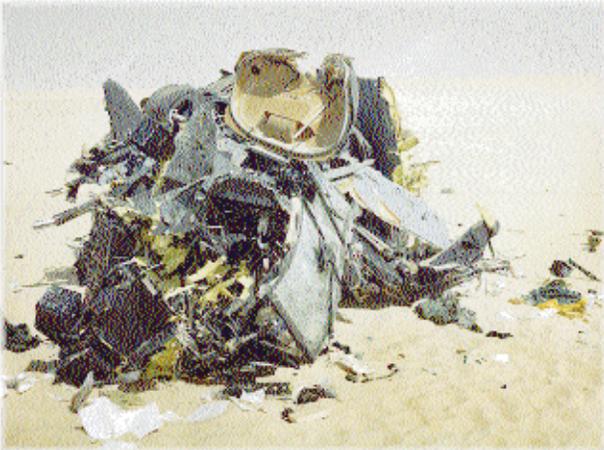
Type I SD: Aircrewmembers are *unaware* that they have an inaccurate perception of their position, attitude, or motion.

During an NVG orientation flight over desert terrain in a UH-60A, the pilot began a descent from 140 feet to his planned altitude of 100 feet. He initiated the descent without informing other crewmembers nor requesting their assistance in warning him if he passed through 100 feet agl. Due to inadequate visual cues, the pilot failed to arrest his descent and struck a sand dune in a near-level attitude at 69 KIAS at a 200-foot-per-minute rate of descent. All five people on board were injured, and the aircraft was destroyed.

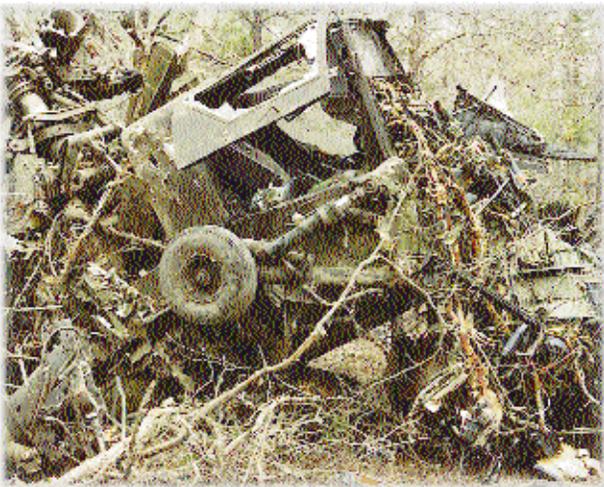
Type II SD: Aircrewmembers are *aware* that SD circumstances exist and must be addressed before safety of flight is irreversibly compromised.

During a night VFR departure and climbout from an unattended stagefield, the AH-64 entered IMC. The pilot on the controls, who was in the back seat, experienced spatial disorientation due to lack of visual cues. He failed to regain control before the aircraft crashed in heavily wooded terrain. He survived, but the front-seat pilot was killed. The aircraft was destroyed.
