Flightfax

ARMY AVIATION
RISK-MANAGEMENT
INFORMATION

NOVEMBER 1998 ♦ VOL 26 ♦ NO 14

Not-so-ready on the firing line

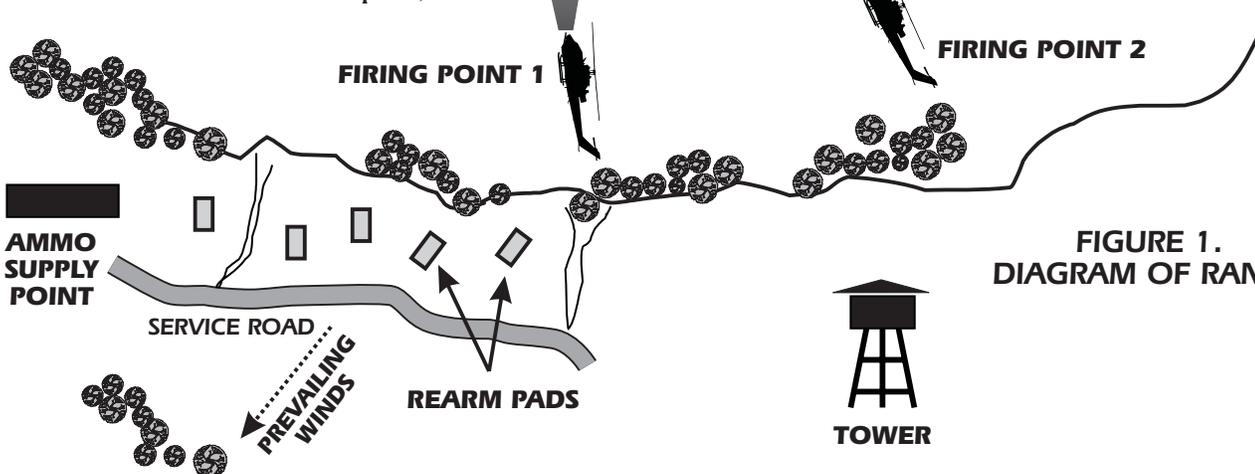
**FIGURE 1.
DIAGRAM OF RANGE**

We had two active rearm pads;

adjacent to them were three pads for parking and troubleshooting (figure 1). The first firing point (FP1) was located 300 meters east and in front of the two rearm pads; the other firing point (FP2) was 500 meters northeast of the tower. We were using both firing points for rockets and 20mm; for TOW, we used only FP2.

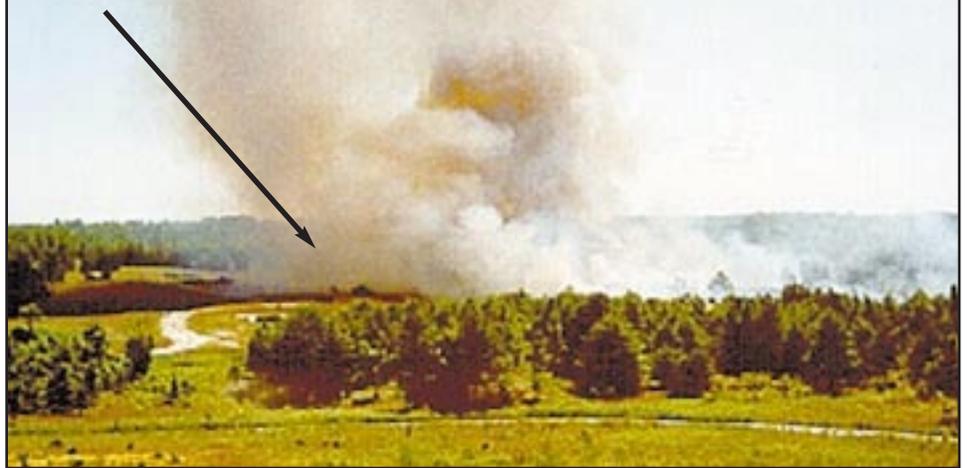
**Range fire has reached critical stage.
The last aircraft is trying to evacuate.**

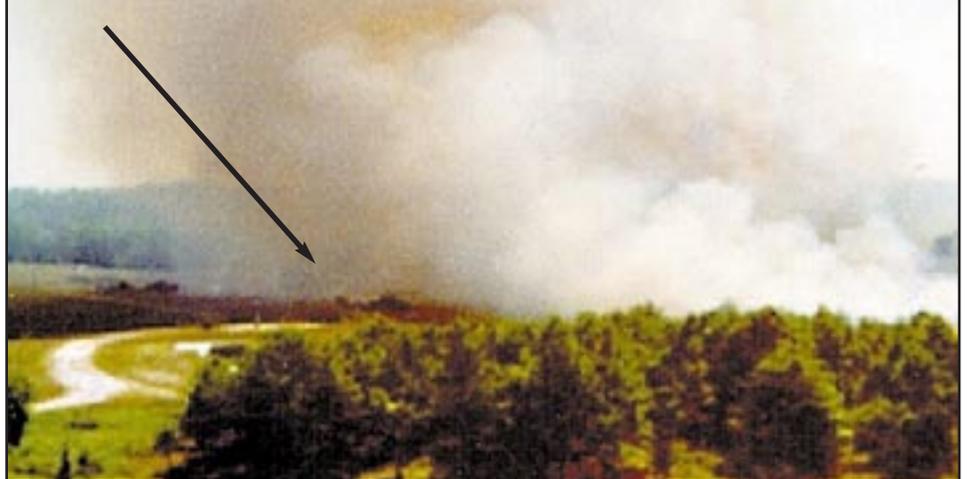
Aircraft is still trying to clear the rearm pad.

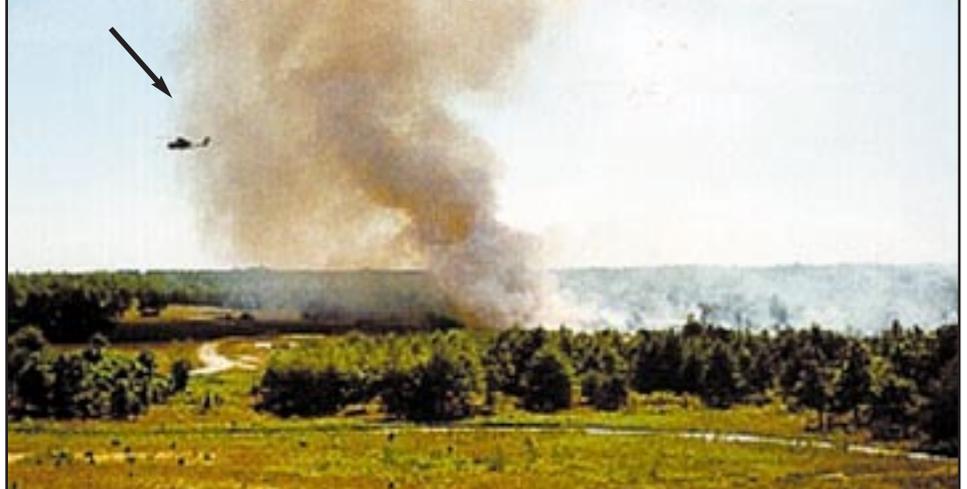
Aircraft finally clears the range.
