Flightfax

ARMY AVIATION
RISK-MANAGEMENT
INFORMATION

JANUARY 1999 ♦ VOL 27 ♦ NO 1

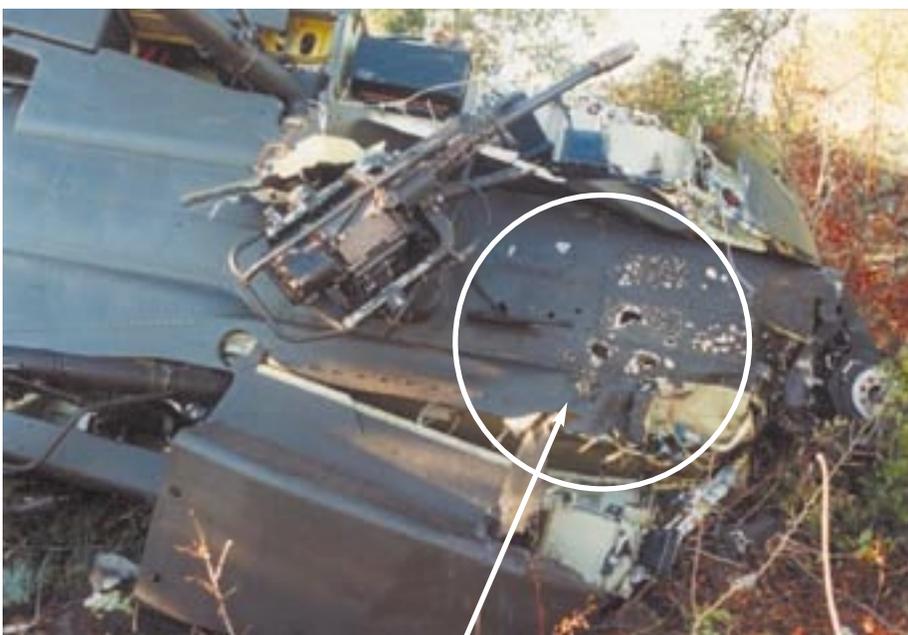
The gun ruptured, resulting in numerous rounds and large fragments penetrating the lower front fuselage, severing or damaging both mechanical and enhanced backup system (EBUCS) flight-control components. The aircraft descended out of control in a spiraling right turn until it hit the ground, resulting in extensive damage. The crew, fortunately, escaped injury.

ROUNDS AND FRAGMENTS SPRAYED UNDERSIDE OF FRONT FUSELAGE.

The fact is that the gun has limitations. The experts at Picatinny Arsenal and AMCOM are currently developing clear and quantifiable limits to be published in the appropriate sections of the operators manual. In the interim, Aviation Safety Action Message (ASAM) AH-64-99-ASAM-01 (011326Z Dec 98) recommends following the existing guidance with the warning: “Failure to adhere to the published gun duty cycle as described in the operators manual may cause a catastrophic failure to the 30mm gun, resulting in loss of aircraft, injury, or death.”

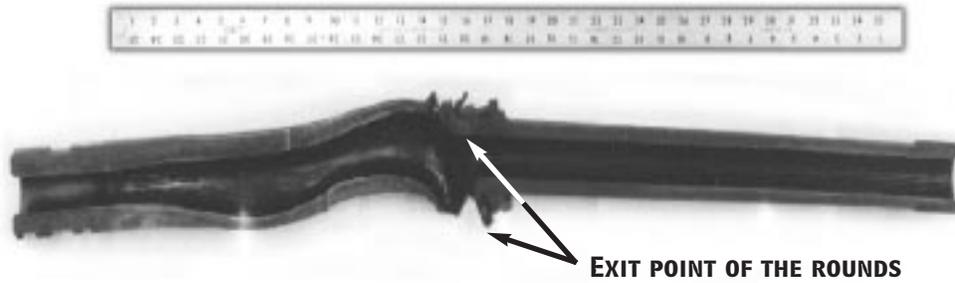
THIS GUN BARREL RUPTURED, RESULTING, IN EFFECT, IN AN APACHE SHOOTING ITSELF IN THE FOOT.

fail? Obviously, the gun will eventually reach a point at which the temperature will cause a misfeed, a lodged round, or other catastrophic failure. Indications appear as round dispersion and sinking round impact, all as the barrel heats and distorts. During the mishap described above, the 30mm reached an estimated 1939°F.
