# Flightfax

ARMY AVIATION  
RISK-MANAGEMENT  
INFORMATION

OCTOBER 2003 ♦ VOL 31 ♦ NO 10

# Emergency Procedures

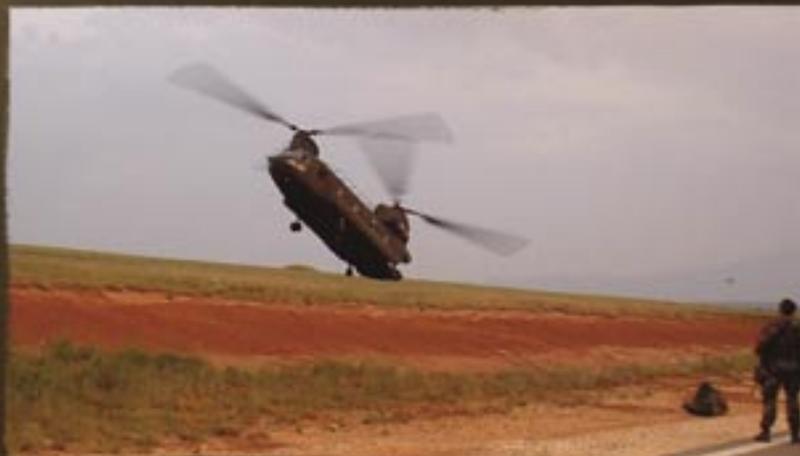
The ultimate cause of this accident was determined to be human error as a result of several factors, including training, unit standards, crew coordination, and risk management. The application of the incorrect emergency procedure contributed to the severity of damage to the aircraft.

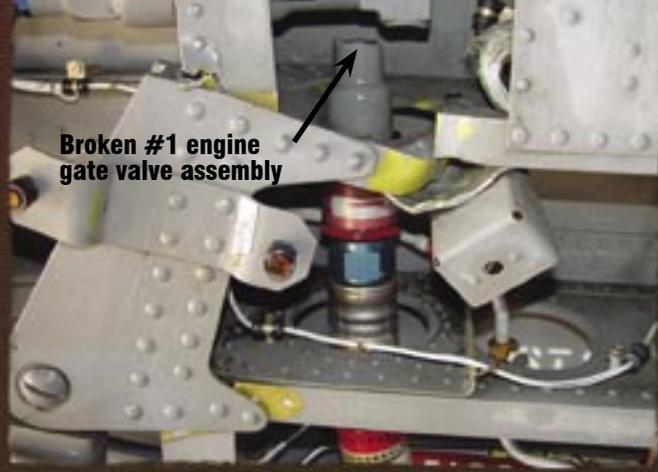
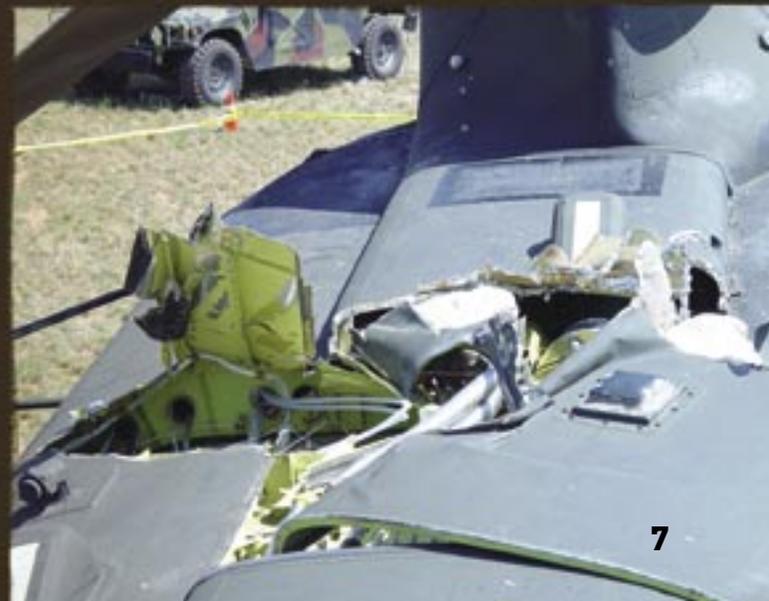
Once upon a time, a CH-47 crew was performing a Fast Rope Insertion/Extraction System (FRIES) mission with 17 Army and U.S. Navy Special Operations Forces (SOF) ropers on board. During the deceleration for the fast rope task, the aft ramp of the aircraft struck the ground hard enough to force the ramp up into the hydraulic struts. The impact caused bending of a sheet metal airframe structural former on the left side of the aircraft.

This bending caused the #1 engine gate valve and mounting bracket to break, spraying fuel in the cabin and on the passengers near the aft ramp. It also created a large fuel vapor cloud due to the rotor wash over the aft ramp. The break in the fuel line fitting immediately starved the #1 engine of fuel, causing it to spool down. The aircraft rebounded slightly and, knowing they now had an emergency situation, the crew leveled the aircraft at about 20 feet above ground level (AGL). The #2 engine immediately began to spool up to meet the now single-engine power demand. The flight engineer (FE) told the pilot (PI) there was a fuel leak and to shut down the #2 engine.

Without hesitation, the PI not on the controls immediately shut down the #2 engine by pulling the #2 engine control lever (ECL) to the STOP position. But he didn't stop there: he then pulled the #2 engine FIRE PULL handle. Oops! This action essentially created a dual engine-out condition, and the rotor RPM began to decay very rapidly. The pilot in command (PC) continued to level the aircraft and applied cushioning collective pitch as the aircraft settled in a forward motion to the ground.

Due to the extremely low rotor RPM, which inhibited the interposer droop stops from engaging in time to prevent rotor droop and subsequent contact of the blades with the fuselage, the synchronizing driveshaft and tunnel cover area received extensive damage. (The interposer blocks are centrifugal force-generated stops that begin to engage at 88.5 percent rotor RPM and are fully engaged at 66.5 percent rotor RPM. They could not position in time due to the rapidly decaying rotor RPM as a result of the induced dual engine-out condition.)

Misdiagnosing the emergency after the impact and subsequent shutdown of the good engine were the primary causes of the extensive damage, since the rapid rotor decay prevented the interposer blocks from positively engaging and preventing the rotor droop. This is a classic example of a minor accident that suddenly

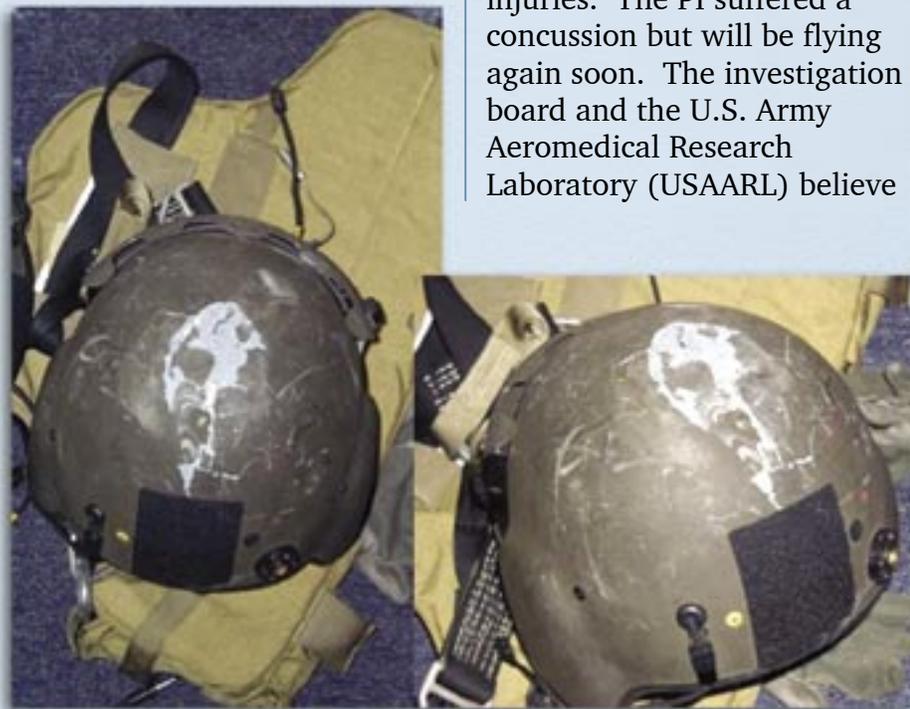
PI's helmet, left seat, knocked unconscious

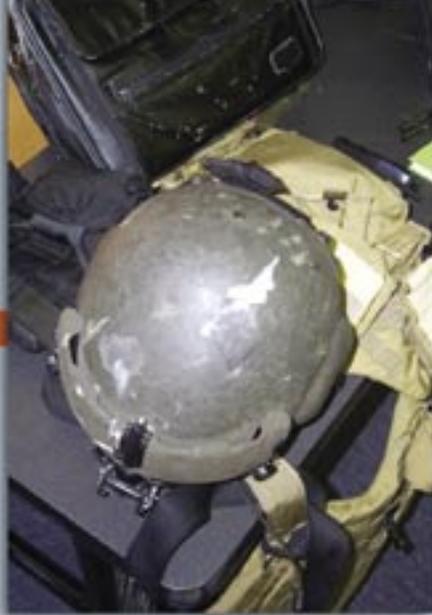
PC's helmet, right seat, no head injury

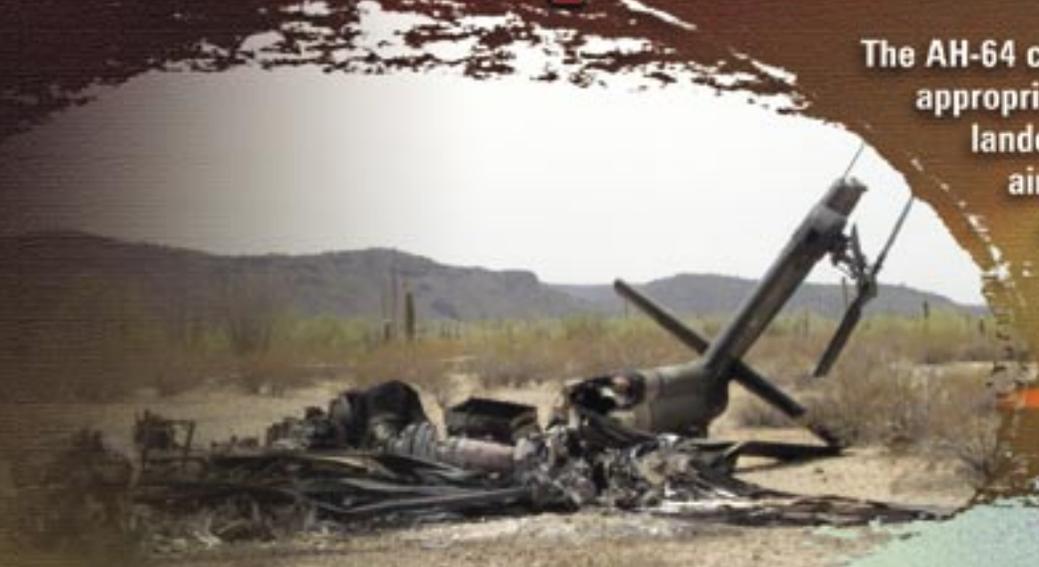
The AH-64 crew performed the appropriate emergency procedures, landed safely, and egressed the aircraft just prior to it being consumed by fire. See "Know Your Equipment" article from July 2002 *Flightfax*.

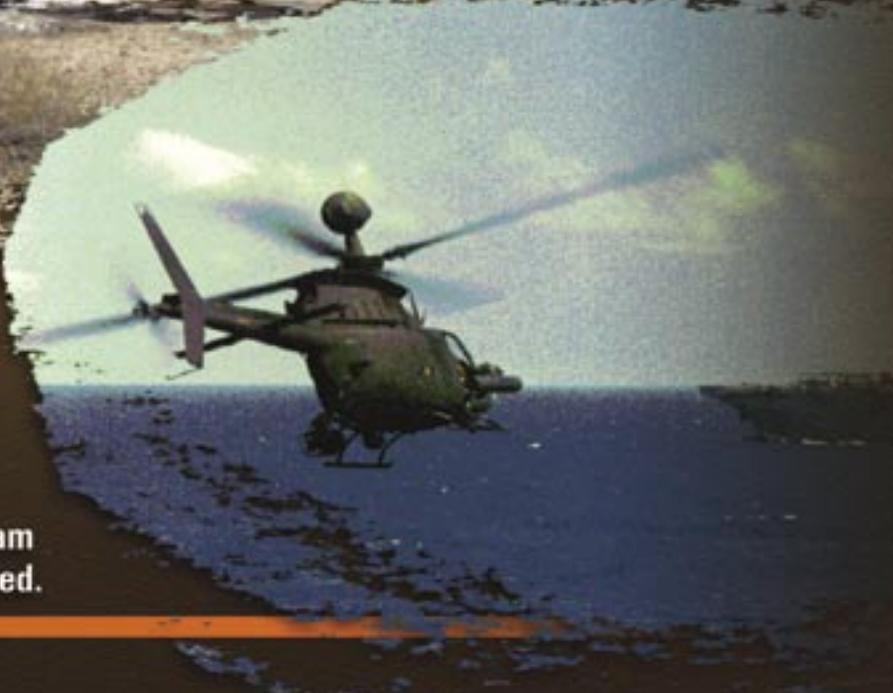
While flying over water, an OH-58D crew experienced a loss of tail rotor components. They executed the emergency procedure and completed what witnesses called a "perfect autorotation." The crew then swam out of the aircraft and were rescued.
