# Flightfax

ARMY AVIATION  
RISK-MANAGEMENT  
INFORMATION

NOVEMBER / DECEMBER 2005 ♦ VOL 33 ♦ NO 12

FY05 Aviation Safety Performance Review ..... 6-9

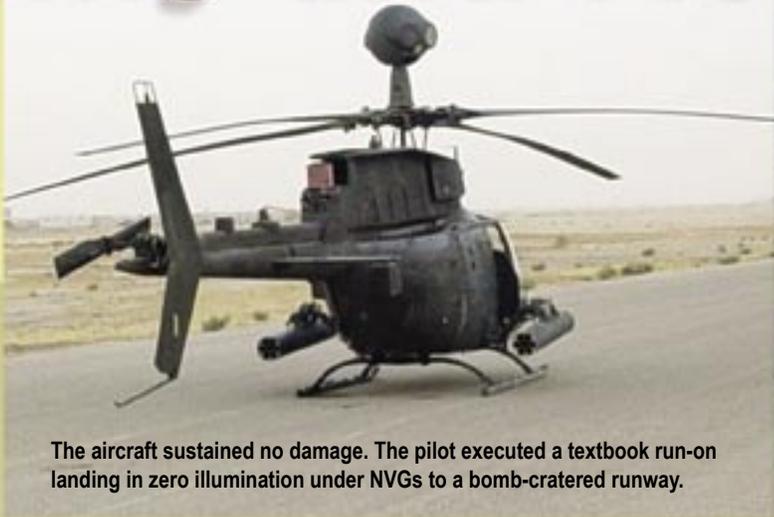
The aircraft sustained no damage. The pilot executed a textbook run-on landing in zero illumination under NVGs to a bomb-cratered runway.

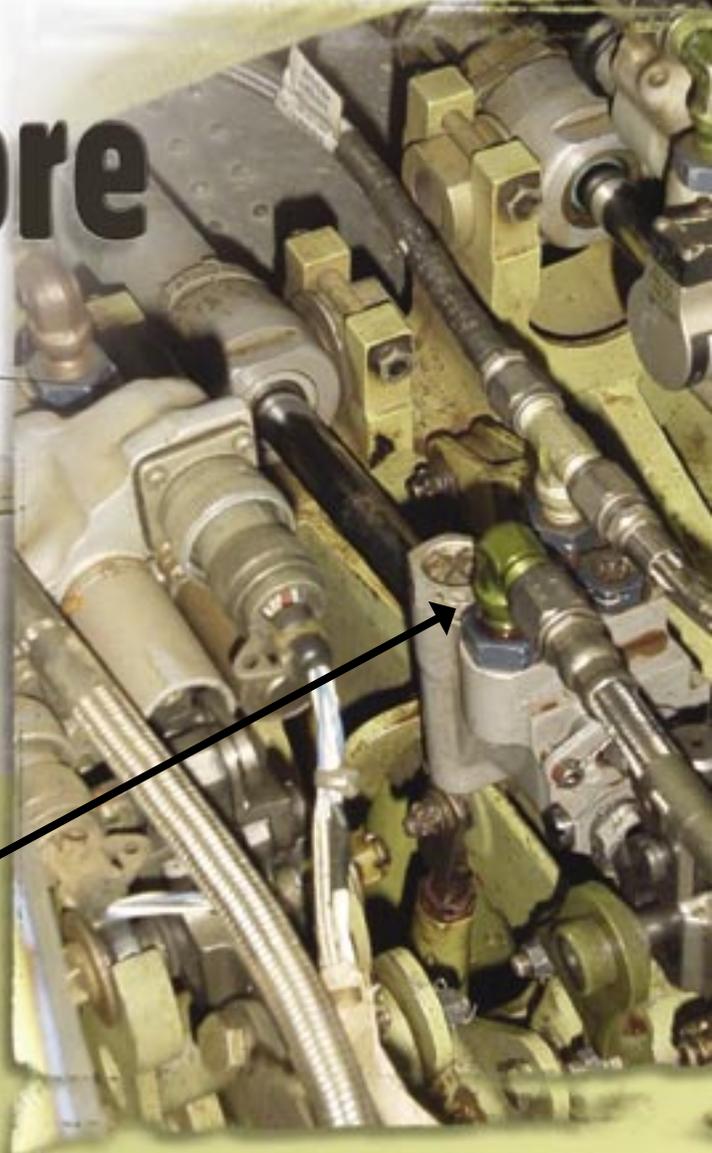
The second picture shows the 90-degree elbow coupling on the center servo that failed, resulting in a complete loss of hydraulic fluid and subsequent emergency. This failure (crack) was undetectable and would never have been found by maintenance unless the line had to be removed for some reason—which it normally isn't. Bottom line: Be prepared for any emergency.
