TF MULESKINNER SAFETY ALERT

AFGHANISTAN 12-18

Welding Safety

What's Wrong Here, you Decide?

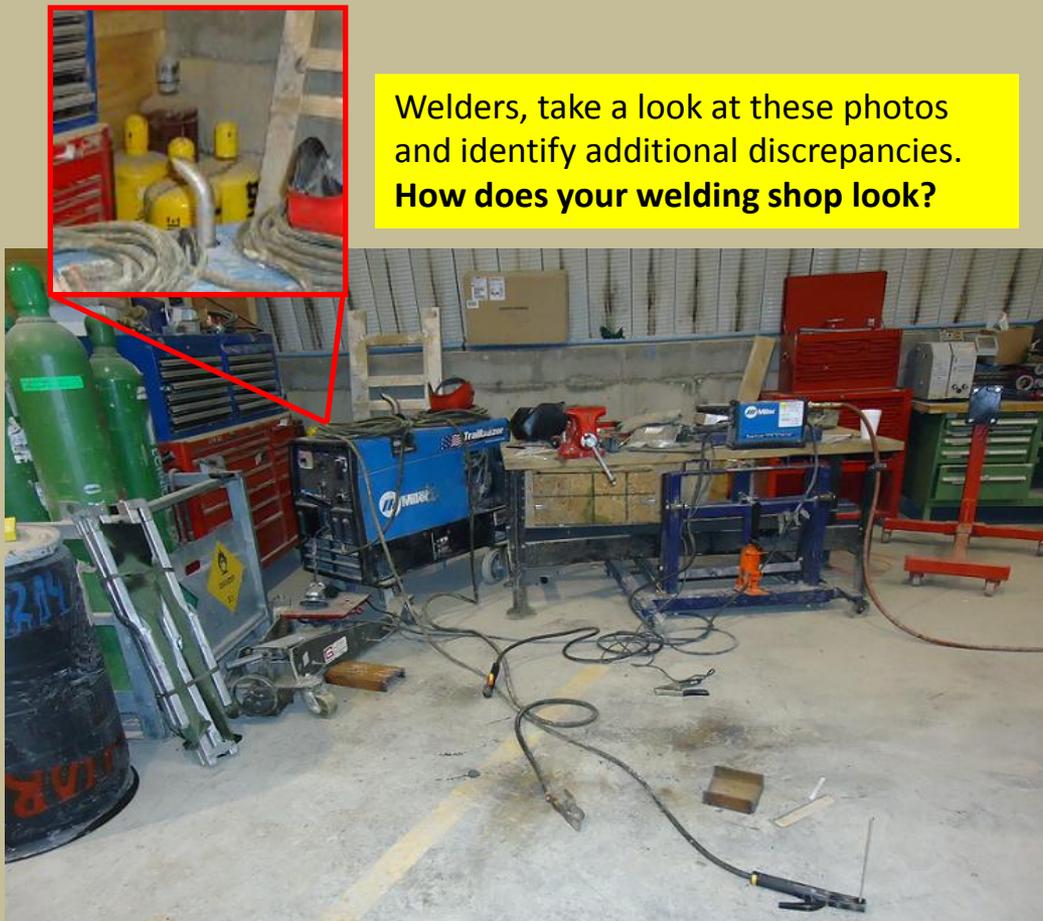
Welders, take a look at these photos and identify additional discrepancies.
How does your welding shop look?

- 1 - Acetylene and Oxygen Tanks – less than 2 feet away from welding operations.
 - 2 - Acetylene and Oxygen separated by 4 feet - (20 feet required).
 - 3 - Wooden wall, and work bench (should be 35 feet away from combustible materials unless shielding or a screen is available).

- 5 - No welding shield or screen available to shield combustibles or personnel exposure.
 - 6 - Welding directly onto concrete.
 - 7 - Welding machine was left with power on.

- 8 - Electrode not removed from holder.
 - 9 - Was a Hot Work Permit issued?
 - 10 - Were MSDS's available for electrodes being used?
 - 11 - What type of metal is being welded?

- 12 - Was a fire extinguisher readily available? **NO**
 - 13 - Was there a fire watch? **NO**
 - 14 - Has Industrial Hygiene conducted air monitoring to assess air quality?

- 15 - Was respiratory protection required? Refer to Industrial Hygiene survey.
 - 16 - Was the correct lenses being used in the helmet?
 - 17 - Had welders received Hazard Communication training?

- 18 - Were hazard signs posted? **NO**
 - 19 - Was all PPE worn including non-flammable clothing?
- Ensure you comply with all safety procedures as eye damage, burns, fires and/or shock and electrocution could occur.**

These photos were taken in a motor pool on a Sunday afternoon, after everyone had left for the day.
