Safety Bulletin

HET DOOR OIF SB-006

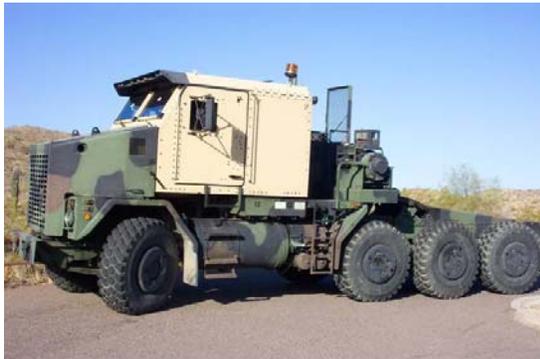
There was great difficulty in opening the doors from inside the vehicle. If under stress, this could prove to be even more difficult.

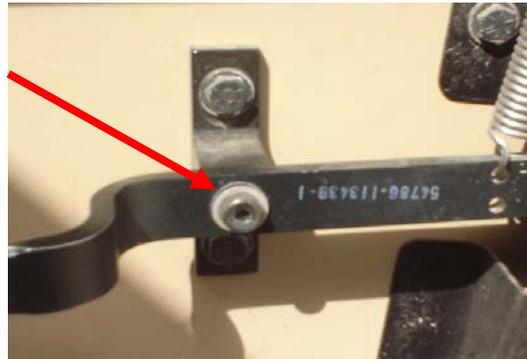
The door handle was very loose, this bolt was finger tight, it is a shouldered bolt and may require an extra washer and also locktite to prevent the bolt from loosening.

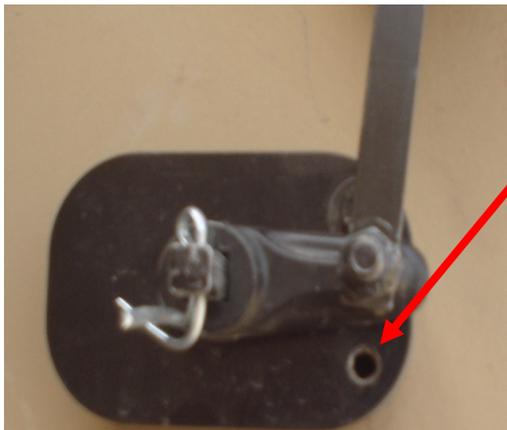
The hardware above was also found to be very loose, and missing a mount bolt.

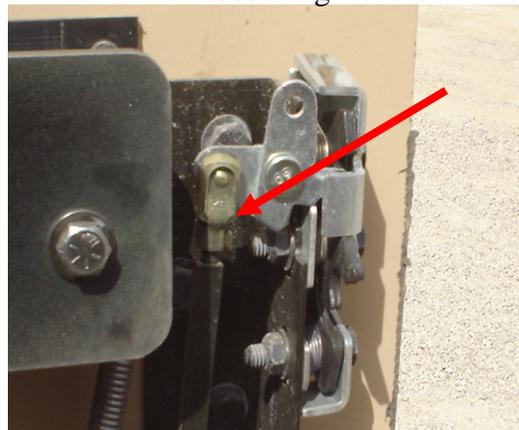
There is an adjustment on this rod that can be made to ease the opening of the door
