Safety Bulletin

MRAP OVERHEAD WIRE HAZARD II MRAP OIF SB-030

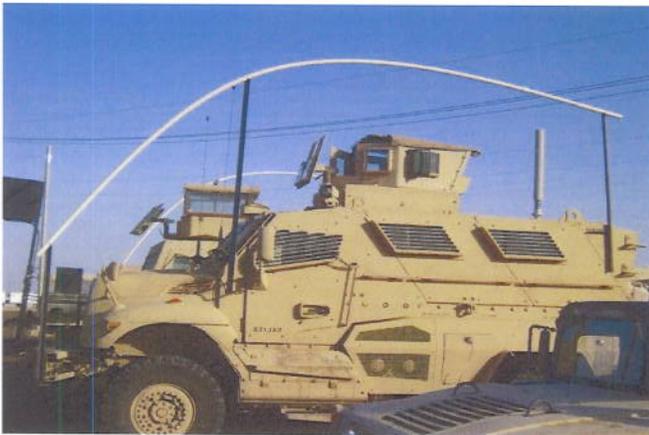
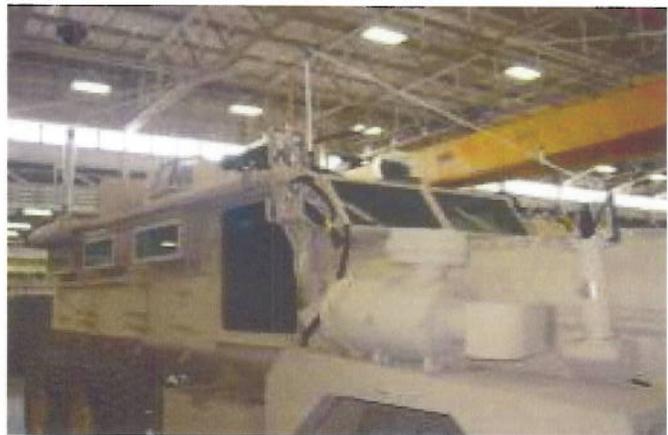
Do's: Use non-metallic materials that are operationally compatible with CREW Systems formed in an arch going from front to rear over items that extend above the roofline of the vehicle. (see photos below) Include a daily inspection of the wire protection system in your daily vehicle checks for serviceability.

Don'ts: Do not use metal materials as an arch over the vehicle; these materials will conduct any electrical current present resulting in possible electrocution. Do not position any metal fasteners on the arch in a manner that could contact the wire.

This addition helps prevent entanglement in wires, it is **not** intended for deliberate or continual deflection of overhead wires.
