# Safety Alert

## Unauthorized Use of Claymore OIF SA-001

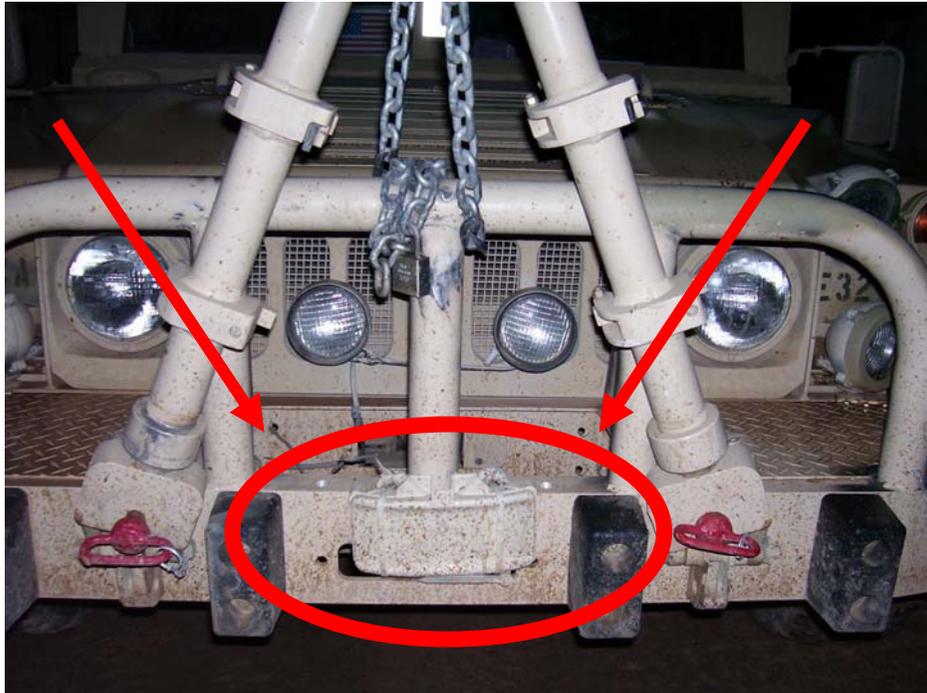
- This picture shows a **LIVE** claymore mounted to the bumper of an HMMWV.
- This is not an authorized deployment method.
- We also must ensure that this is not standard TTP.

MND-B Commander Prohibits Non-Standard Employment of Weapons (FRAGO 107)

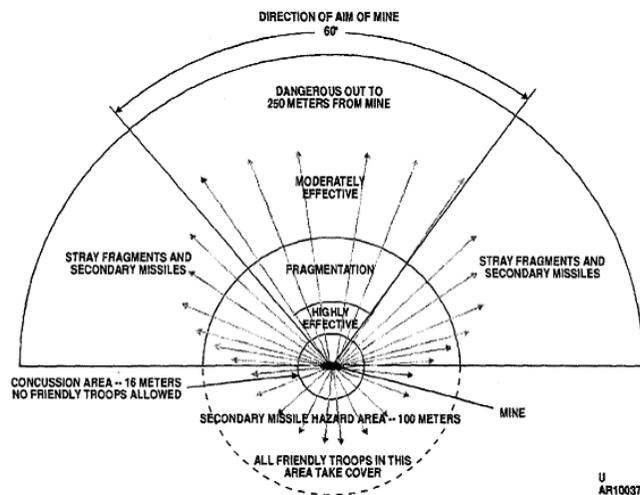
2-14

Figure 2-9. Casualty and danger areas of antipersonnel mine M18A1.

The Claymore has a significant backblast area as detailed above. At a minimum, the blast would disable the vehicle and at worst, kill the vehicle operator and TC as it blasted out the windshield.
