FLIGHT *fax*

Army Aviation Composite Risk Management Information

**"The Cockpit
as a Battle
Space"**

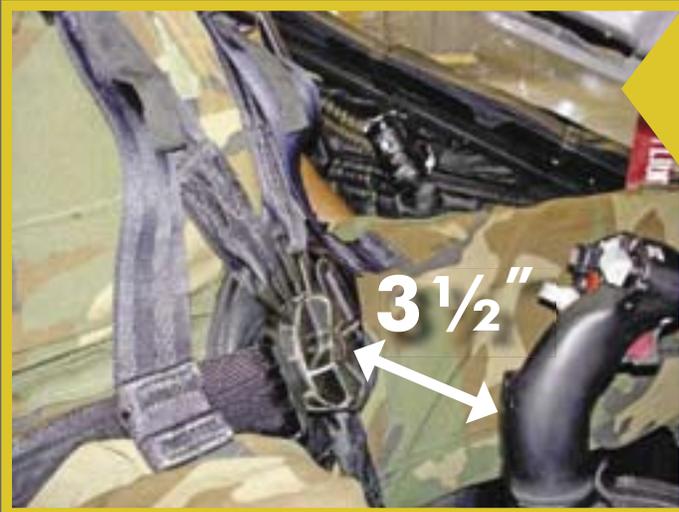
LAP BELT BUCKLED

more than 270 pounds. Although he could fasten all the belts on the seat restraint, fastening the lap belt was extremely uncomfortable for him, so he often didn't do it. On this flight, the front-seat pilot's lap belt restraints were not fastened, which allowed him to slide forward and down in his seat. The board determined the pilot's position just prior to the accident allowed the PC on the controls the use of only 46 percent of available aft cyclic travel. Once he had initiated the turn, the backseat PC attempted to apply aft cyclic to steepen the turn and climb to clear the hill to the left. When he realized the aircraft was not

responding with what he thought was full aft cyclic, the PC attempted to level the aircraft and conduct a cyclic climb. Once again, however, he could not complete the maneuver due to the front-seat pilot's forward position blocking the cyclic.

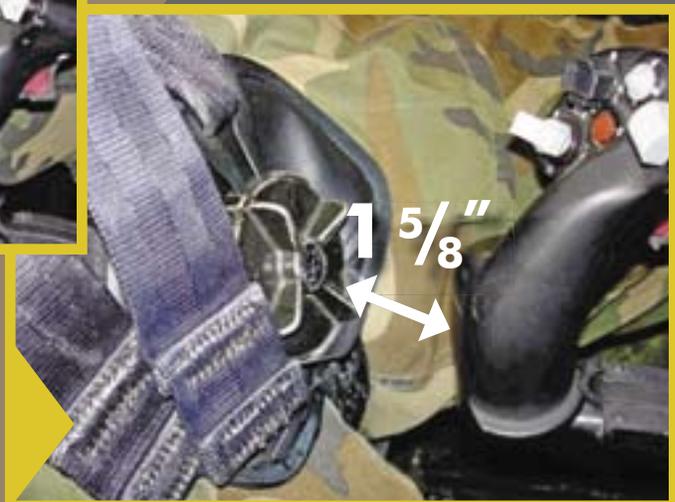
LAP BELT NOT BUCKLED

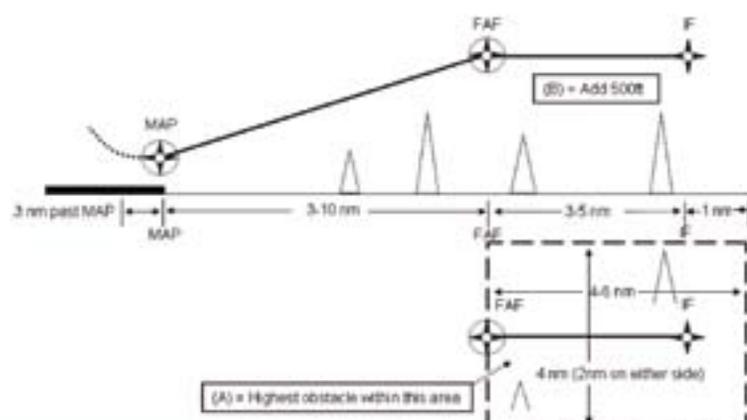
Final Approach Fix (FAF) Altitude

(Intermediate Approach Segment)

Determine highest obstacle from: 1nm before IF to FAF and 2nm laterally= (A) _____

Solution: (A) _____ (rounded up nearest 100 ft)+ (B) 500ft = (C) _____ (FAF)

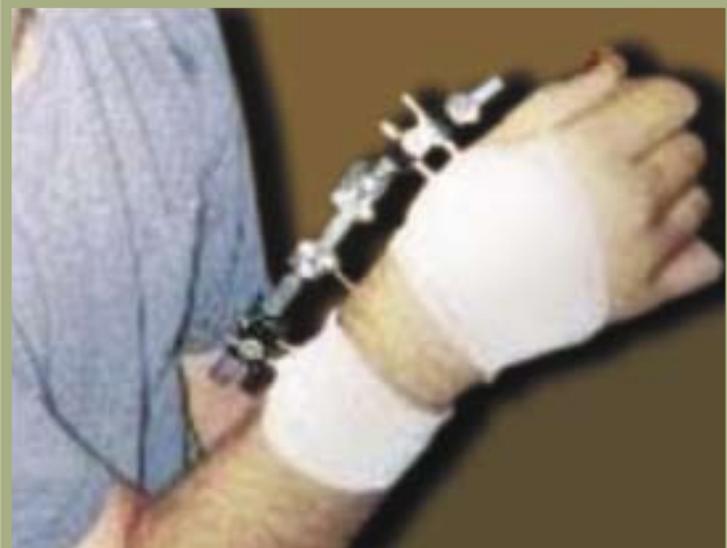
► External fixator approximately one month post-surgery.

external fixator and surgery to repair. Thankfully, after many months of healing and therapy, I regained enough use of my wrist to continue my aviation career.
