Flightfax

January 1993 Vol 21 No 4

REPORT OF ARMY AIRCRAFT ACCIDENTS

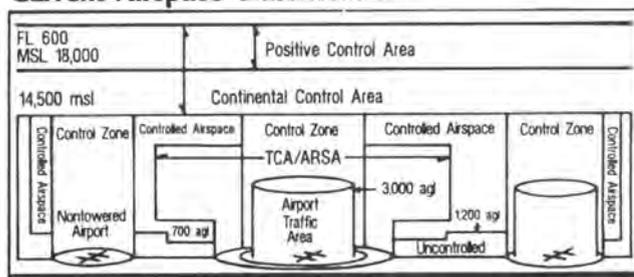
Current Airspace Classification

On page 6 of the November 1992 issue of *Flightfax*, the two charts showing FAA airspace classifications were incorrectly captioned and the effective date of the second chart was incorrect. The new airspace classification charts began appearing on 15 October 1992 and will become effective on 16 September 1993. The graphics with the correct captions are shown below.

msl - mean sea level
agl - above ground level
FL - flight level
