Flightfax

ARMY AVIATION
RISK-MANAGEMENT
INFORMATION

FEBRUARY 1998 ♦ VOL 26 ♦ NO 5

**WHAT WE DON'T KNOW
CAN HURT US!**

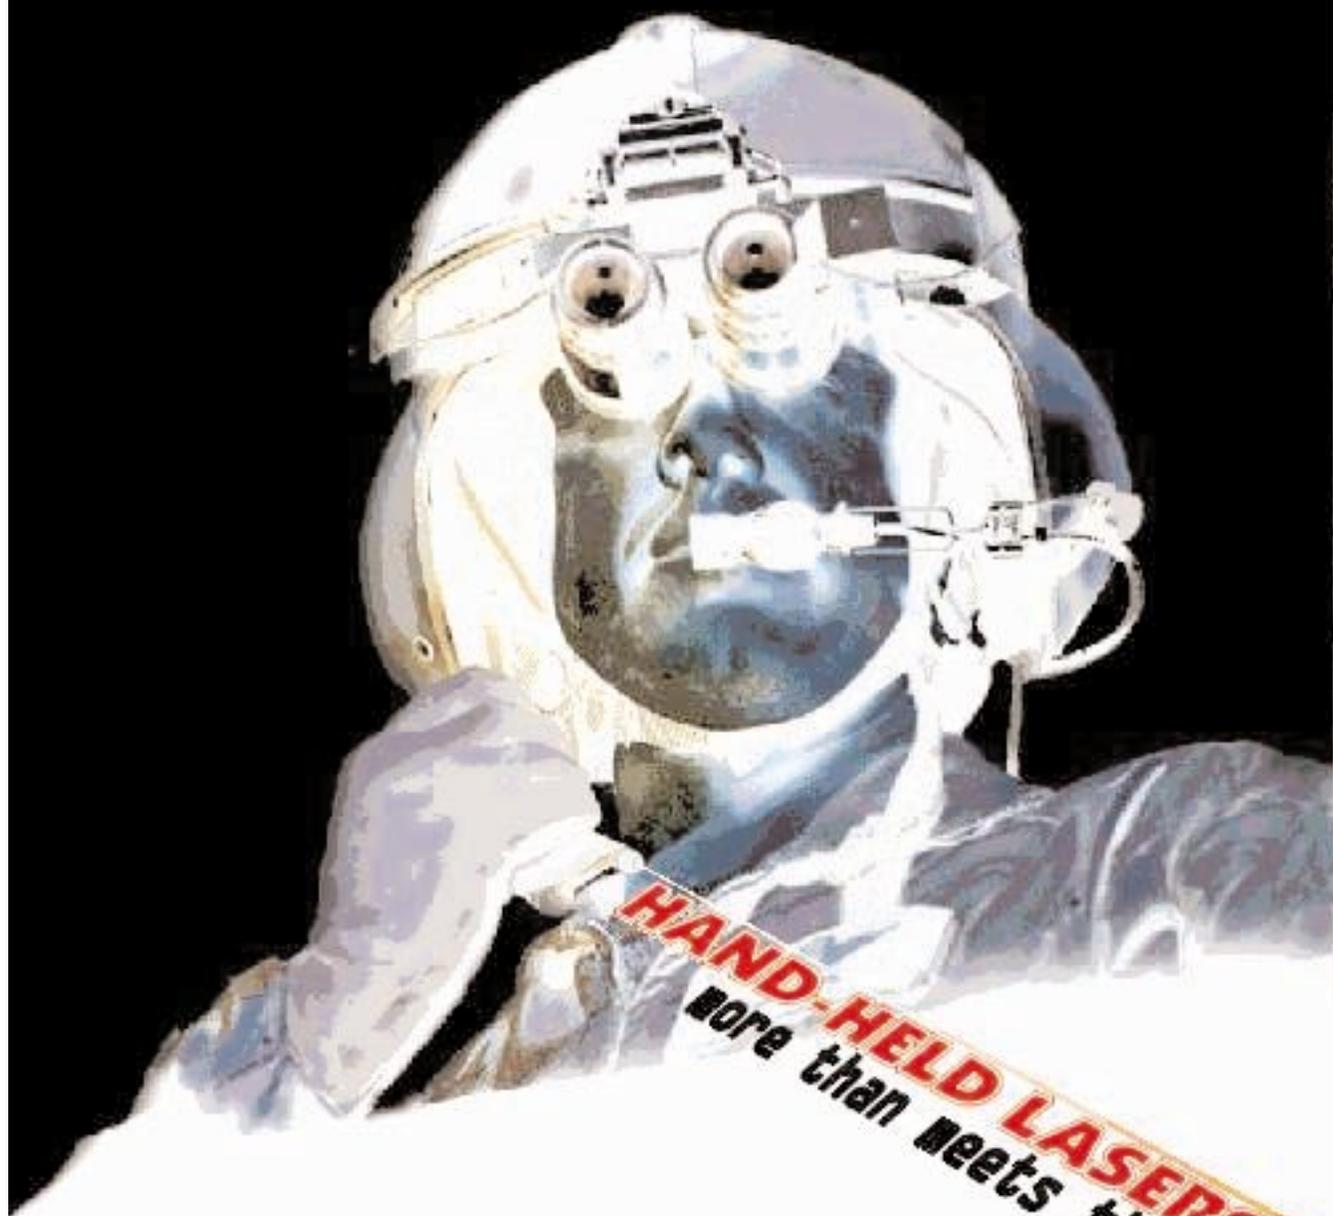
HAND-HELD LASERS:
More than meets the eye

WHAT YOU CAN'T SEE CAN HURT YOU!

Treat laser as
loaded weapon
Develop/practice
crew coordination
Never look into laser
Use low-power
near-IR devices
Know and follow
unit SOP for use

Class 3B hand-held lasers such as the LPL-30 long-range laser pointer and the GCP-1 ground commanders pointer can range in power from 5 milliwatts (mW) to 500mW. At the higher levels, they can cause serious eye injury if used improperly. The major hazard is to the unprotected eyes of users who look at the laser from within the direct beam.

The problem is, these lasers emit energy that is invisible to the unaided eye. As a result, users sometimes tend to look into the business-end of the device to try to ascertain whether or not it's working. With these near-infrared lasers, even if users looked at the beam at very close range, the most they'd see would be a very weak red dot of light, if that. But staring into the laser from within the beam can cause
