Flightfax

ARMY AVIATION
RISK-MANAGEMENT
INFORMATION

MAY 1999 ♦ VOL 27 ♦ NO 5

Bosnia success story:
Managing risk in
real-world operations

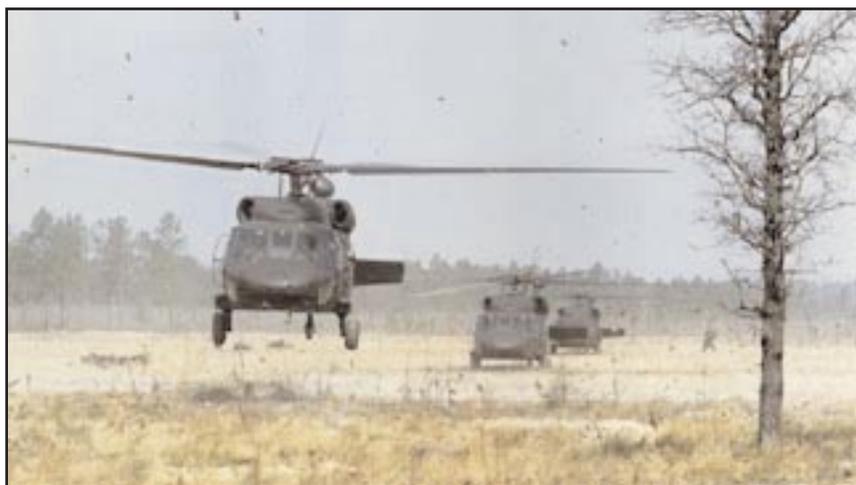
UH-60 dual engine rollback

Numerous misconceptions exist within the UH-60 community regarding the phenomenon known as "dual engine rollback" (DER). This article will discuss the history of this phenomenon and clarify what is and what isn't a DER.

An engine failure that occurs when single-engine capability does not exist and exceeding power available are not dual engine rollbacks. In addition, maneuver-induced transient rotor droop is often wrongly perceived to be a DER. Pilots have induced transient rotor droop and believed they corrected a DER with the trim switch; in reality, the engine control unit corrected the transient droop.

A DER is a reduction of rotor speed (Nr) and the power-turbine speed (Np) of both engines from 100 percent to a lower value (during flight or on the ground) that was not maneuver-induced transient rotor droop and where trim switch activation is not considered likely. In some cases, incidents in which Nr/Np's fail to reach 100 percent on start-up are also considered by investigators to be DERs.

Typically, a dual engine rollback results in Np's and Nr decreasing simultaneously to between 94 and 96 percent. In some events, Nr/Np's as low as 92 percent were reported. In one event, Nr/Np's fell low enough to shut down instrument displays, but maneuver-induced transient droop probably caused the Nr/Np's to reach such low values.
