Flightfax

ARMY AVIATION
RISK-MANAGEMENT
INFORMATION

FEBRUARY 2000 ♦ VOL 28 ♦ NO 2

POOR DECISIONS TRAGIC RESULTS

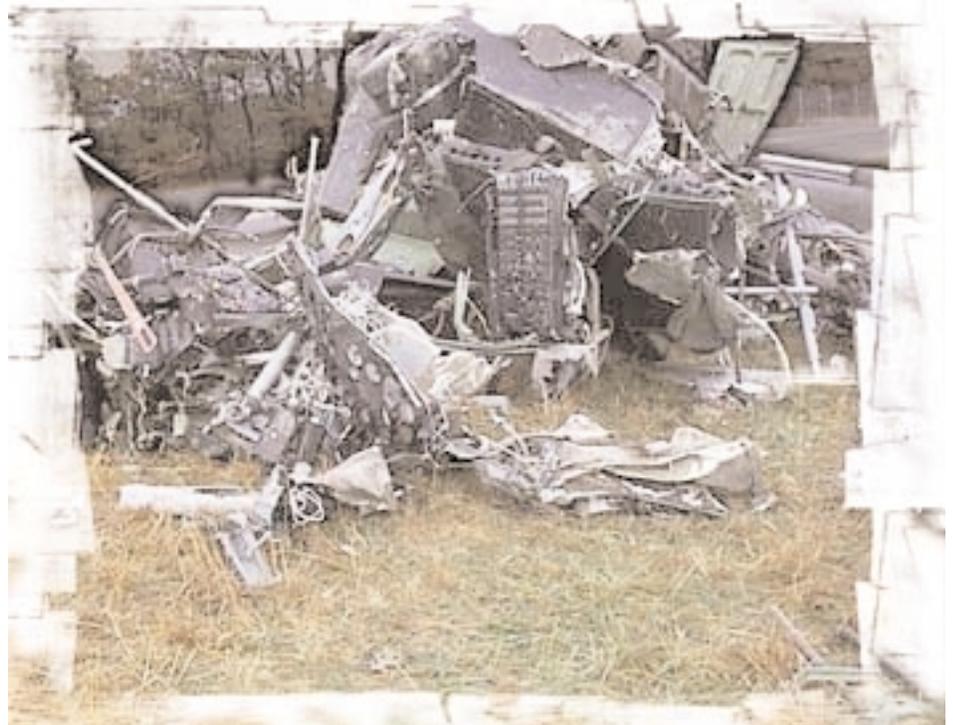
Radar data shows that the crew flew on course down to localizer minimums. Several hundred feet short of the runway the aircraft track began to veer left of course. The aircraft slowed to 60 knots

and descended another 100 feet as it traveled 3/10 of a nautical mile past the runway approach end. At this point, radar identification was lost. From the last known radar position, the aircraft turned approximately 180 degrees and traveled the 3/10 nautical miles back towards the approach end of the runway. At 2017, 4 minutes and 20 seconds after crossing the outer marker, the aircraft impacted the ground. The aircraft was in a 30-degree nose-down level attitude.

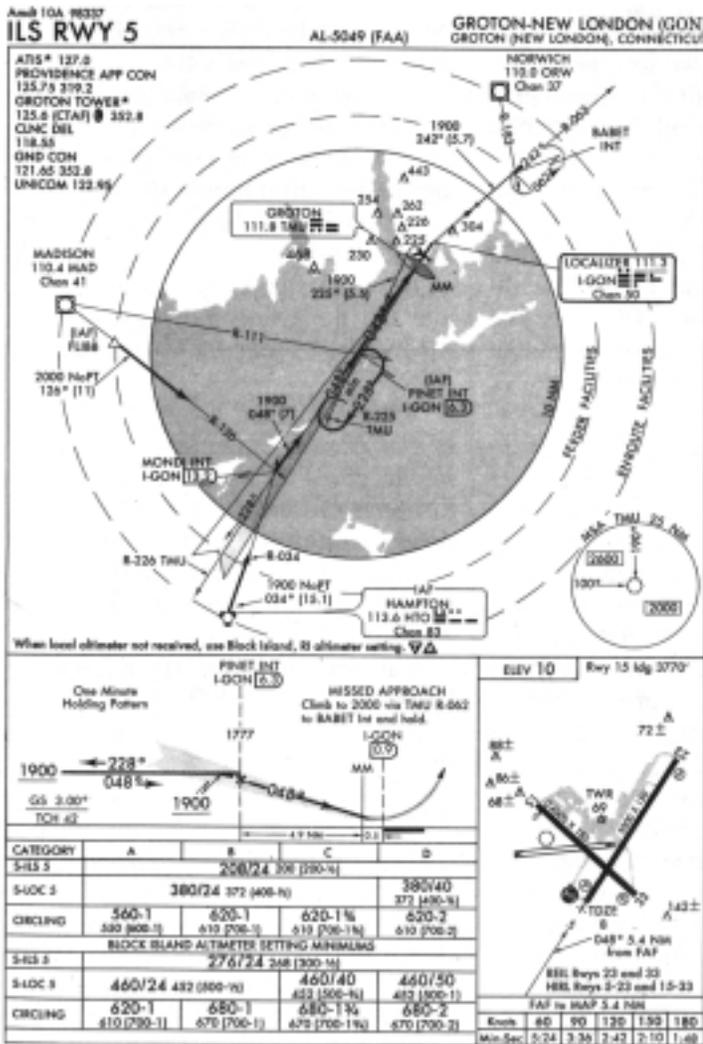
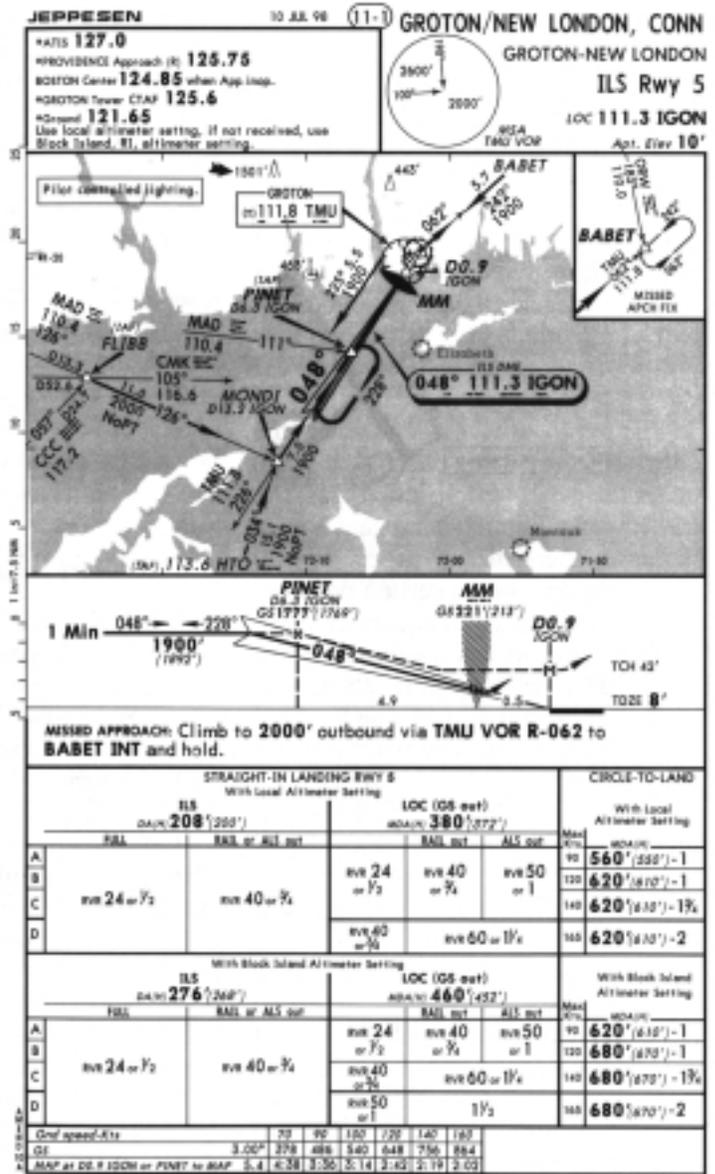
IFR QUIZ • COLD ILS APPROACH

This ILS takes you across the frigid waters of Long Island Sound to the Connecticut coast.

1. The minimum safe altitude for this procedure is based on—
