Flightfax

ARMY AVIATION
RISK-MANAGEMENT
INFORMATION

JULY 2005 ♦ VOL. 33 ♦ NO. 7

Crew Coordination Special Issue

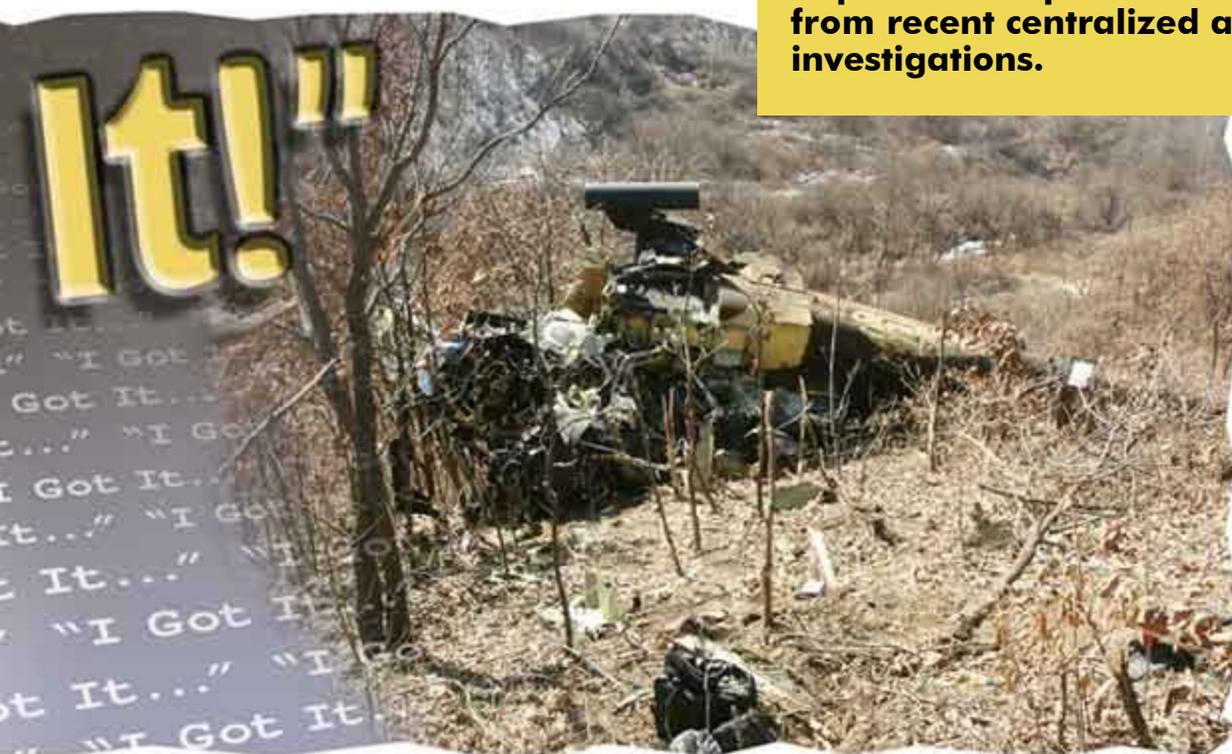
down, 13-degree left bank, impacted a 44-degree upsloping hillside with its nose. Both cockpits received severe structural damage during the initial impact. After the initial impact, the aircraft rebounded skyward and developed an extremely nose-low attitude. The aircraft then fell nearly straight down on its nose and impacted the ground a second time. The aircraft came to rest predominantly upside down on its right side, leaning against its mast-mounted assembly. Both pilots suffered fatal injuries.

The centralized accident investigation (CAI) board determined no one was operating the flight controls for the 11 seconds preceding the accident. The backseat pilot's "I got it" referred to his receipt of the target grid coordinate; he never placed his hands or feet on the flight controls. The front-seat pilot misinterpreted the backseat pilot's "I got it" to mean he'd assumed responsibility of the

flight controls. Head tracker information from the maintenance data recorder corroborates the CAI board's conclusion, showing both pilots were looking inside their respective cockpits for the last 11 seconds of the flight.

seconds later, the aircraft impacted a hillside, killing both pilots. Both crewmembers had been focused on receiving target grid coordinate information and neither pilot was flying the aircraft at the time of impact. The front seat pilot had relinquished the flight controls before ensuring the backseat pilot had assumed control of the aircraft.

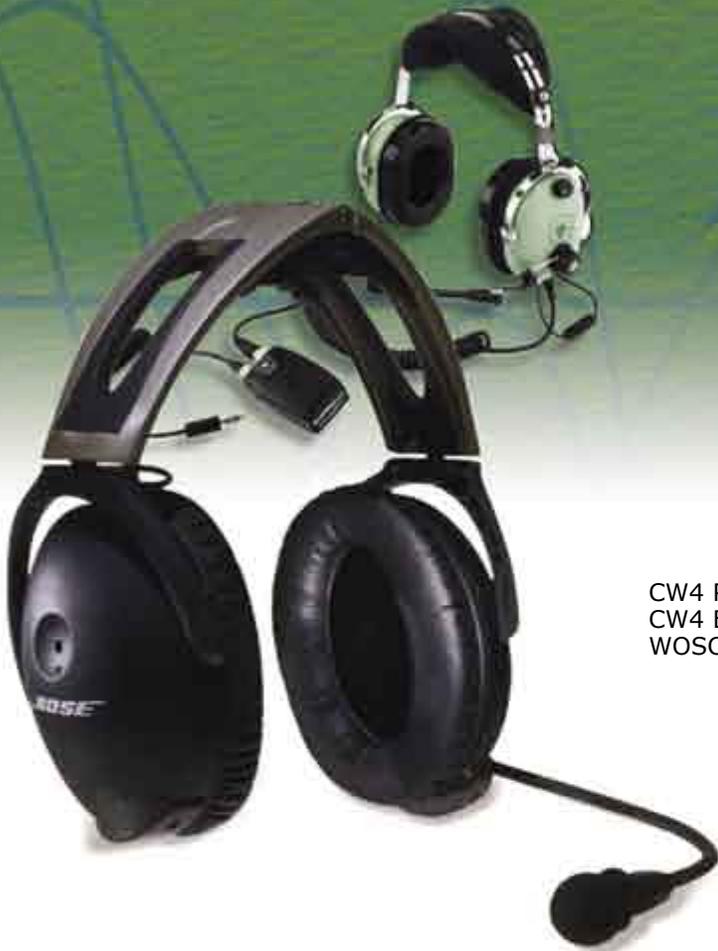
The Right Headset in Your Fixed-Wing Aircraft

inside the ear cup, noise entering from the flight deck through the ear cup is sensed and analyzed by an electronic circuit. The electronic signal is inverted, amplified, and transmitted through the earphone canceling out the noise, whether you are actively talking or just listening to the radio or another crewmember. Most of the electronic noise-canceling technology headsets are failsafe in that they provide individual circuits for both the ANR portion and the radio/intercom portion of the headset. If the headset power source (battery pack) or ANR electronics fail, the headset will continue to function for communications.

In accordance with testing performed at the U.S. Army Aeromedical Research Laboratory, Fort Rucker, AL, by Dr. A.J. M. Houtsma, Ph.D., both the Bose AHX 32-01 and David Clark (DC) P/N 40862-01 perform very well at reducing exposure to hazardous noise levels. Testing was performed at a flat 108 dB(A) for frequencies starting at 63 Hz extending to 4,000 Hz.

reduced the sound level below the Army's 85-decibel threshold for hazardous noise, and above 300 Hz, reducing it below the OSHA standard of 80 decibels. After turning the ANR on, this headset performed very well at reducing the low frequencies well below the 80-decibel level and maintained the higher frequencies well below 80 decibels.

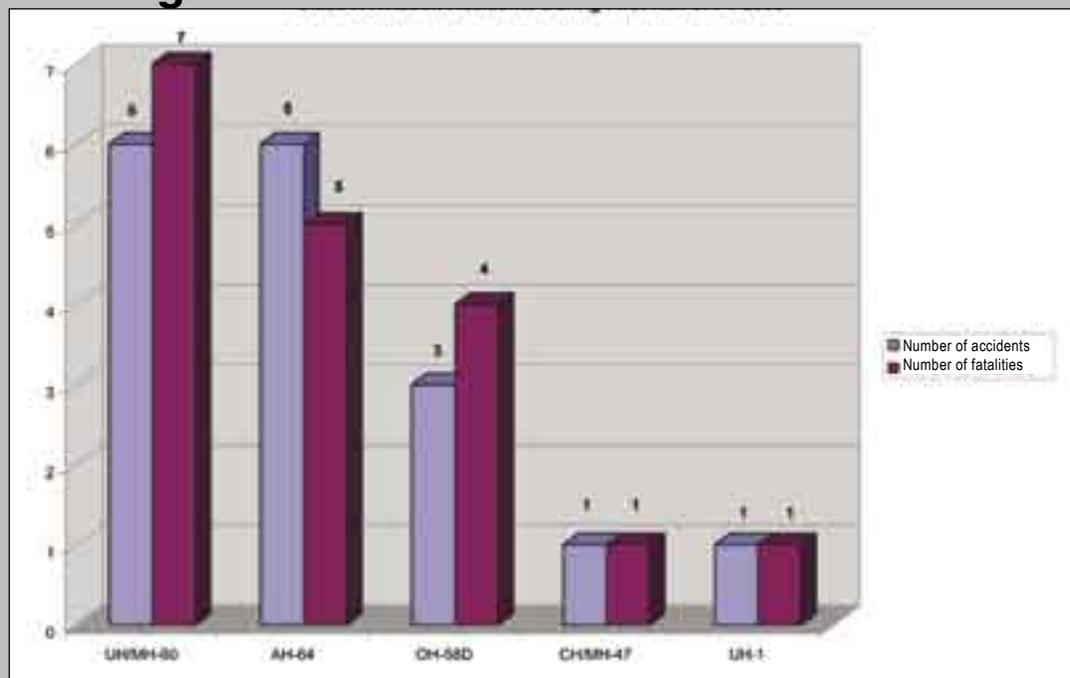
Class A Aviation Accidents During First Half of FY 2005

- An AH-64D crew was performing day gunnery training. The pilot had initiated a right break while safeing the weapons system. The aircraft descended to ground impact and was destroyed, one pilot received fatal injuries and the other pilot was injured.

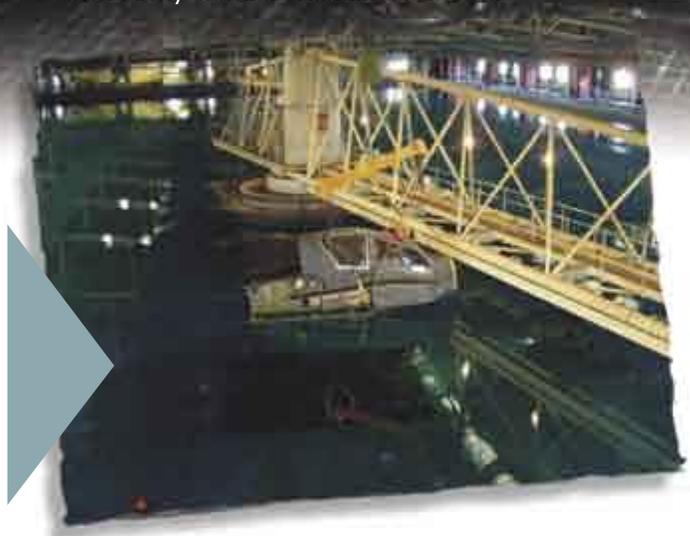
AH-64A/D COCKPIT Jettison system

Test results

The testing confirmed that the CJS will function when the aircraft is submerged and the crew stations are full of water; BUT initiation of the CJS, when the crew stations are full of water, generated a pressure wave that would be fatal to the crew. Even in instances where the crew stations are only partially filled with water, the shock wave could propagate through the water and affect any submerged body parts. Depending on the overall level of crewmember submersion, this could also prove fatal. Additionally, immediately after activating, the CJS pieces of the cockpit transparencies were forced into the crew stations by the inward water pressure. Some of these pieces were large enough to impede egress and would have to be moved to allow crewmembers to escape.

If the Canopy Jettison System has not been activated prior to ditching in water, the external water pressure may cause the canopies to implode (collapse inward) as the aircraft sinks beyond 2 to 3 meters. The cockpit will flood almost immediately and the aircraft will
