FLIGHT *fax*

Army Aviation Composite Risk Management Information

ALSE: Survival

- 2 COVER STORY:**
ALSE: Survival Gear for Soldiers
on the Edge
- 4** ALSE: Present But Not Contributing
- 6 INVESTIGATORS' FORUM:**
Why You Should Wear Your Helmet
- 9** Mastering the High-Frequency Radio
- 12** Survival Radios...Who Needs Them?
- 14** Who Knows What Could Happen?
- 15** CEPs, the Noise Countermeasure
- 18** Our Aviation Brigade is Deploying
OCONUS, What Boots Can We Wear?
- 20 NEWS AND NOTES:**
 - Removal of Aspirin from
ALL ALSE Vests
 - New HGU-56/P NSNs
 - Chitosan Dressings
- 21** LITEFAX
- 22** ACCIDENT BRIEFS
- 24** POSTER: It's a Matter of Survival

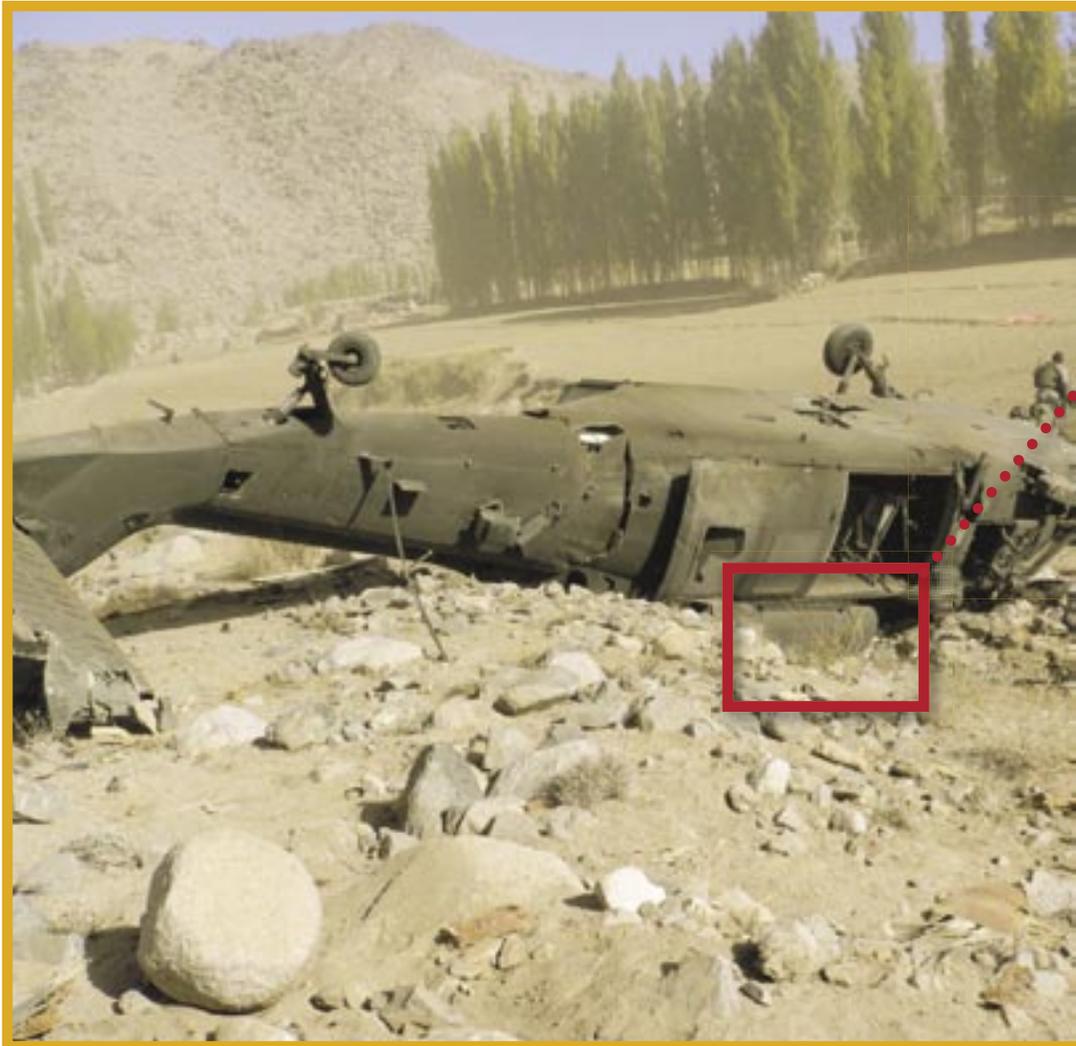
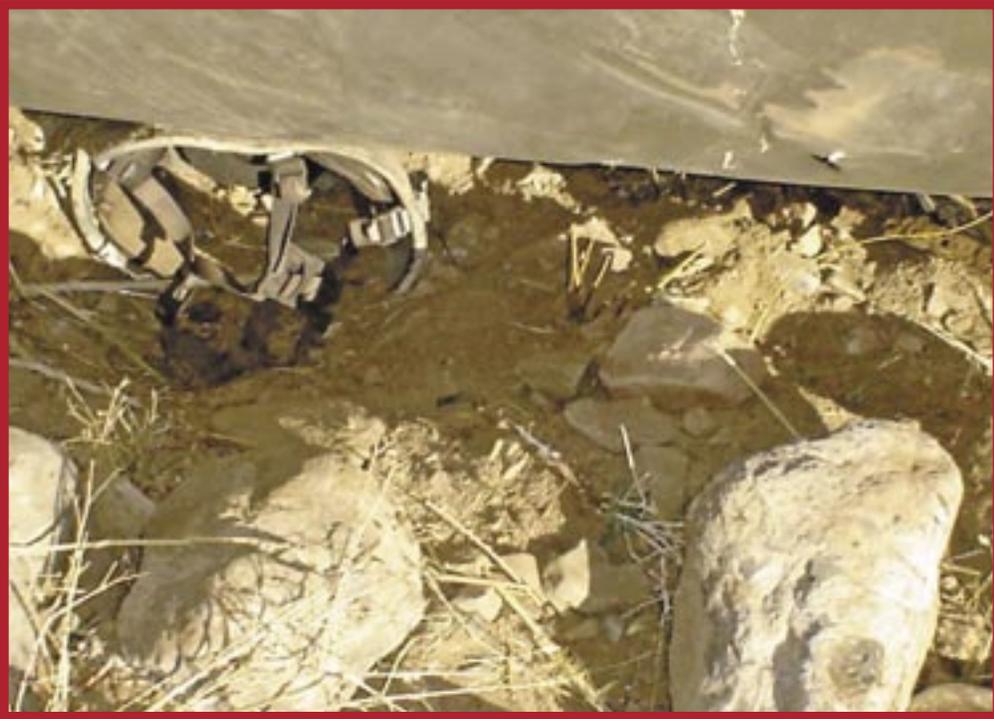
The helicopter shredded its rotor system and rolled over, trapping the ejected Soldier's head under the aircraft's left side.

The helicopter shredded its rotor system and rolled over, trapping the ejected Soldier's head under the aircraft's left side. Fortunately, he was wearing his Kevlar® helmet, which remained intact even under the weight of the aircraft (see photos). The Soldier was evacuated to a medical facility and is expected to make a full recovery.

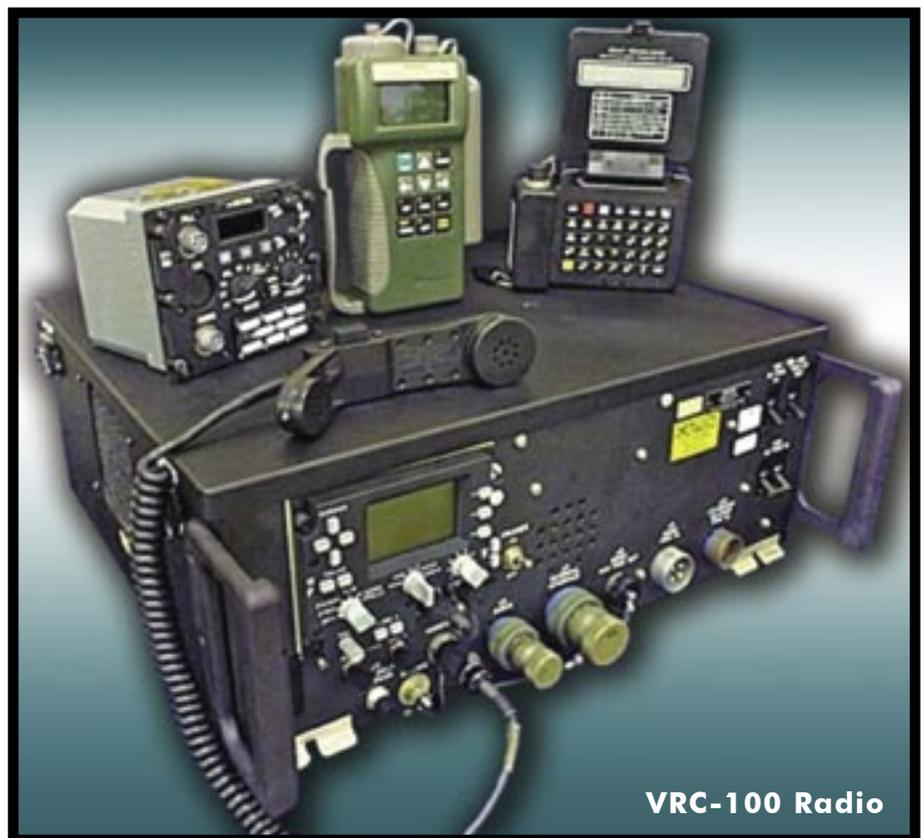
VRC-100 Radio

There are several components required to reliably communicate with the HF radio. One is the VRC-100, which is the ground base station. The VRC-100 can be placed in a fixed-base station like flight operations, the

TOC, or it can be operated from a vehicle such as a jump TOC. Whether or not secure communications are required, the radio is most reliable if linked to the KY-100, a digital encryption device. Secure communications are obtained when a crypto variable is loaded into the KY-100 via the CYZ-10 data transfer device. Say that 10 times fast!

This radio is not designed to operate in the single-channel mode. Due to radio wave propagation and changes in atmospheric conditions, the most reliable communications are obtained in the ALE mode. ALE takes the hard work out of HF communications. Once an ALE database is obtained, it is stored on a computer system (desktop, laptop, or Miltope) and becomes available to load to the CYZ-10.

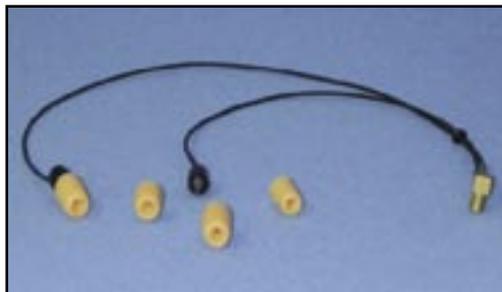
Figure 1. CEP with different cord lengths

As with most pieces of safety equipment, proper fitting is critical to getting the best performance. Not properly following CEP use instructions will affect performance and can jeopardize user comfort. The CEP is comprised of two primary components: the screw-on foam tips and the CEP. The wires attached to the CEPs are of two different lengths (fig. 1). The short wire is for the CEP worn in the right ear. The longer wire permits the CEP for the left ear to be routed either behind the head or under the chin.

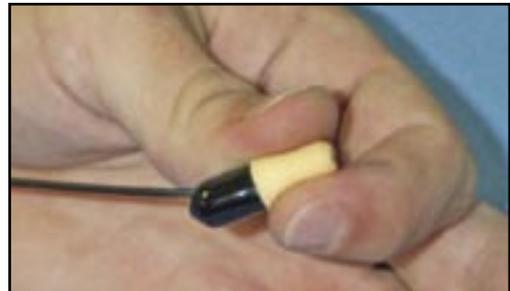
Figure 2. Foam eartip being compressed

Before wearing the CEP, the foam eartips are screwed onto the threaded tubes of the CEP until the foam touches the CEP housing. At the point the foam just touches the housing, tighten an additional quarter turn. This seats the inner portion of the eartip with the recessed area of the transducer base. Take the foam tip and the CEP between the thumb and first two fingers (fig. 2) as one unit and roll the foam portion down to a small diameter (just like a typical foam earplug).

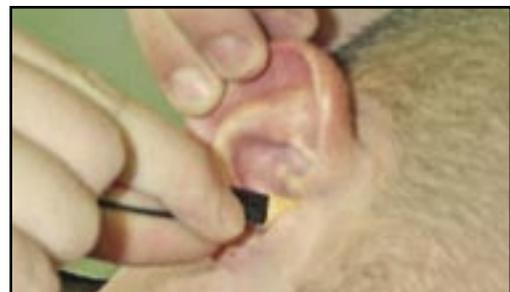
Figure 3. Pulling external ear to straighten ear canal

Once the foam is compressed, insert the eartip into the ear canal until the transducer body is inside the external ear. To get the eartip properly inserted in the ear canal, it is important you pull your external ear up and out to the side with your free hand while inserting the eartip (fig. 3). This straightens the ear canal and eases insertion of the foam tip. Very little foam should be visible at the ear canal opening if correctly inserted (fig. 4). **NEVER FORCE OR SHOVE THE TIP INTO THE EAR CANAL.** Position the transducer housing during the insertion so the wire will exit comfortably.

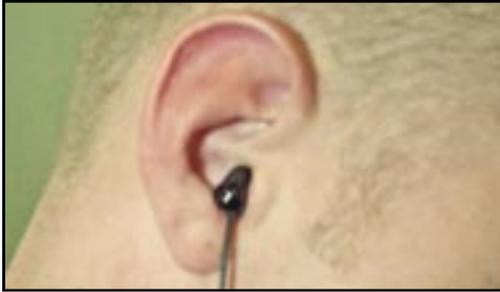
Figure 4. CEP properly positioned

The procedure is then repeated for the other ear. At this point, you are ready to put on your flight helmet. When donning the helmet, spread the ear cup areas slightly. Pulling the helmet straight down over the ears may cause the CEP to be moved.

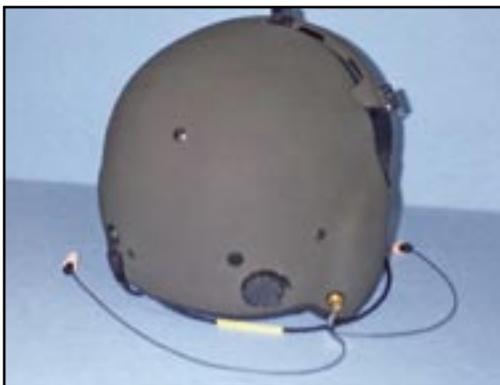
Figure 5. HGU-56/P with CEP installed

The CEP connector is inserted into the mating connector located on the lower right back edge of the helmet (fig. 5). The connectors are coaxial and easy to connect and disconnect. When the SMB plug on the CEP is lined up with the SMB jack on the helmet, push the plug until it is fully seated.

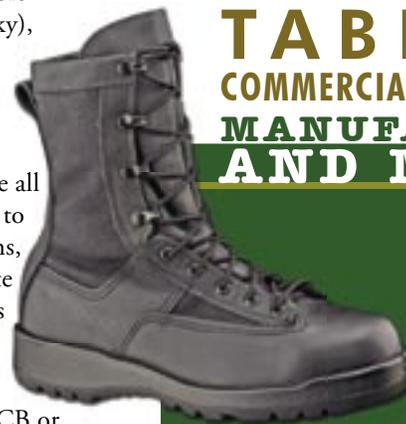
TABLE OF COMMERCIAL ACB(TW) BOOT MANUFACTURERS AND MODELS

If you requisition the ACB(TW) using the NSNs, you will get a boot authorized for aircrew use. If you chose to order ACB(TW) boots commercially, the table below shows the commercial names or model number designations:
