# FLIGHT *fax*

*Army Aviation Composite Risk Management Information*

**“Survival Gear  
for Soldiers  
on the Edge”**

## ALSE: Survival

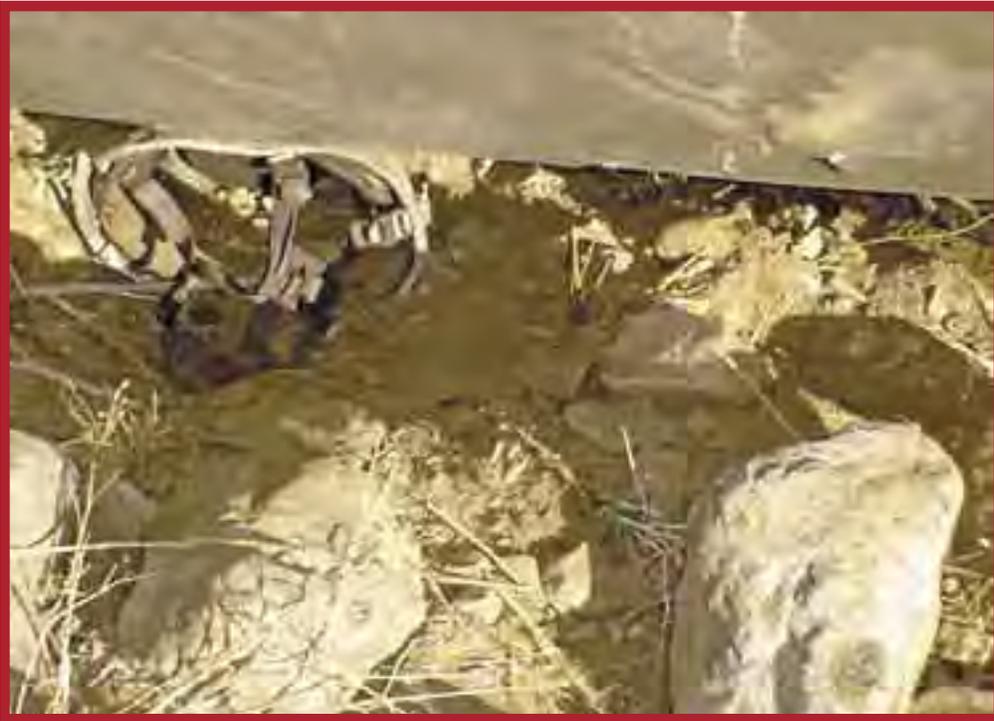
**T**he helicopter shredded its rotor system and rolled over, trapping the ejected Soldier's head under the aircraft's left side.

The helicopter shredded its rotor system and rolled over, trapping the ejected Soldier's head under the aircraft's left side. Fortunately, he was wearing his Kevlar® helmet, which remained intact even under the weight of the aircraft (see photos). The Soldier was evacuated to a medical facility and is expected to make a full recovery.

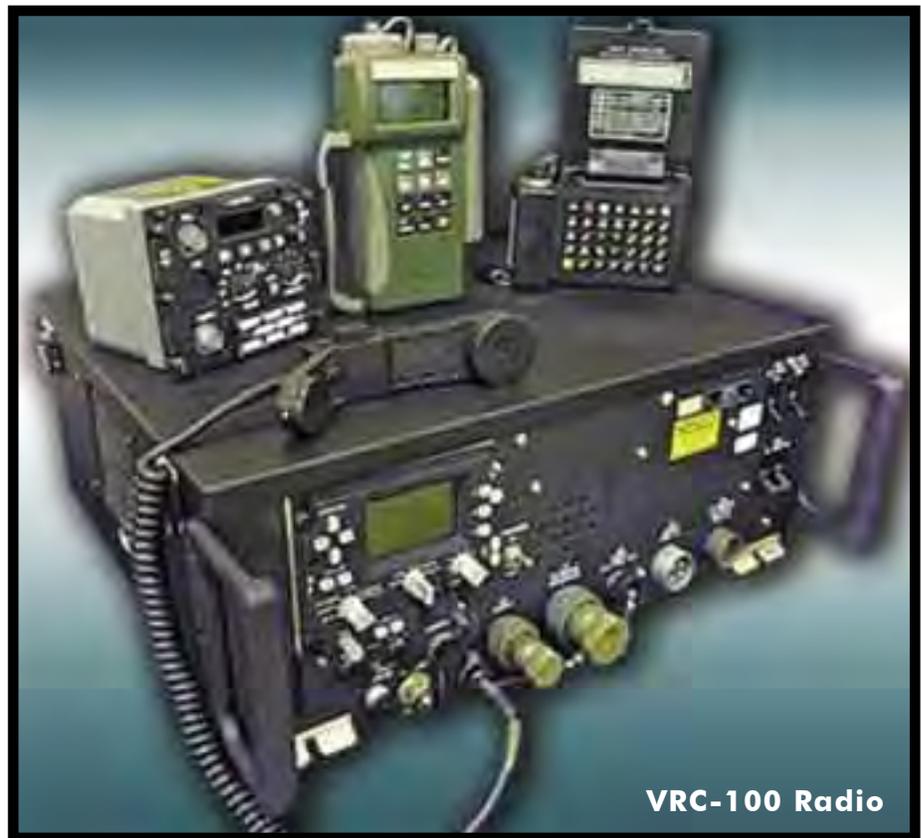
There are several components required to reliably communicate with the HF radio. One is the VRC-100, which is the ground base station. The VRC-100 can be placed in a fixed-base station like flight operations, the

TOC, or it can be operated from a vehicle such as a jump TOC. Whether or not secure communications are required, the radio is most reliable if linked to the KY-100, a digital encryption device. Secure communications are obtained when a crypto variable is loaded into the KY-100 via the CYZ-10 data transfer device. Say that 10 times fast!

This radio is not designed to operate in the single-channel mode. Due to radio wave propagation and changes in atmospheric conditions, the most reliable communications are obtained in the ALE mode. ALE takes the hard work out of HF communications. Once an ALE database is obtained, it is stored on a computer system (desktop, laptop, or Miltope) and becomes available to load to the CYZ-10.

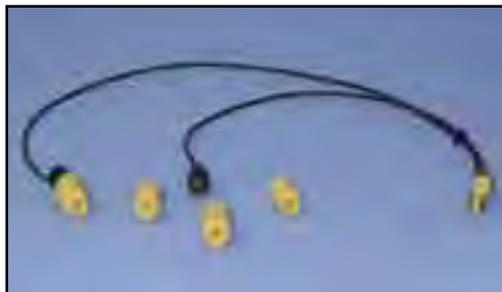
Figure 1. CEP with different cord lengths

As with most pieces of safety equipment, proper fitting is critical to getting the best performance. Not properly following CEP use instructions will affect performance and can jeopardize user comfort. The CEP is comprised of two primary components: the screw-on foam tips and the CEP. The wires attached to the CEPs are of two different lengths (fig. 1). The short wire is for the CEP worn in the right ear. The longer wire permits the CEP for the left ear to be routed either behind the head or under the chin.

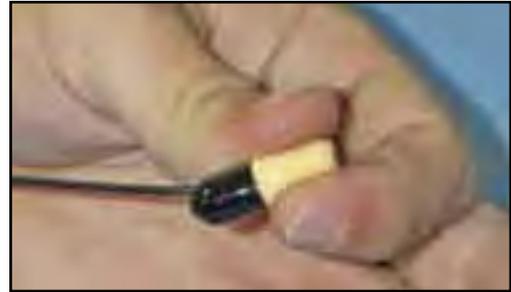
Figure 2. Foam eartip being compressed

Before wearing the CEP, the foam eartips are screwed onto the threaded tubes of the CEP until the foam touches the CEP housing. At the point the foam just touches the housing, tighten an additional quarter turn. This seats the inner portion of the eartip with the recessed area of the transducer base. Take the foam tip and the CEP between the thumb and first two fingers (fig. 2) as one unit and roll the foam portion down to a small diameter (just like a typical foam earplug).

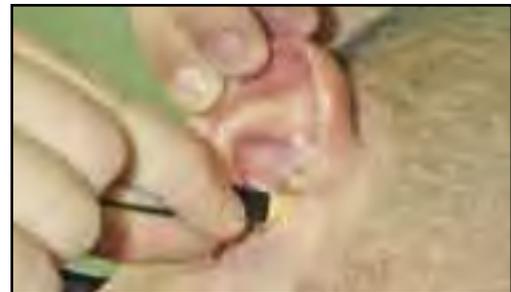
Figure 3. Pulling external ear to straighten ear canal

Once the foam is compressed, insert the eartip into the ear canal until the transducer body is inside the external ear. To get the eartip properly inserted in the ear canal, it is important you pull your external ear up and out to the side with your free hand while inserting the eartip (fig. 3). This straightens the ear canal and eases insertion of the foam tip. Very little foam should be visible at the ear canal opening if correctly inserted (fig. 4). **NEVER FORCE OR SHOVE THE TIP INTO THE EAR CANAL.** Position the transducer housing during the insertion so the wire will exit comfortably.

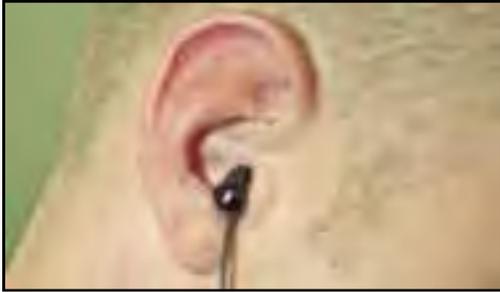
**Figure 4. CEP properly positioned**

The procedure is then repeated for the other ear. At this point, you are ready to put on your flight helmet. When donning the helmet, spread the ear cup areas slightly. Pulling the helmet straight down over the ears may cause the CEP to be moved.

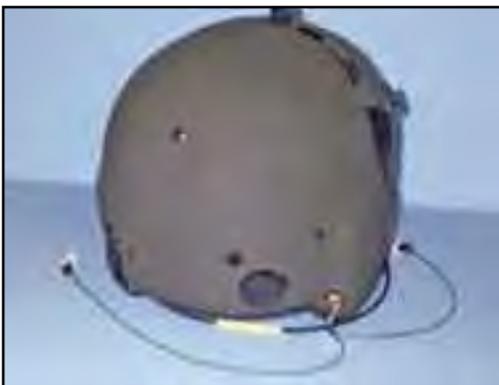
**Figure 5. HGU-56/P with CEP installed**

The CEP connector is inserted into the mating connector located on the lower right back edge of the helmet (fig. 5). The connectors are coaxial and easy to connect and disconnect. When the SMB plug on the CEP is lined up with the SMB jack on the helmet, push the plug until it is fully seated.
