FLIGHT *fax*

Army Aviation Composite Risk Management Information

**"System Safety:
For the Soldier"**

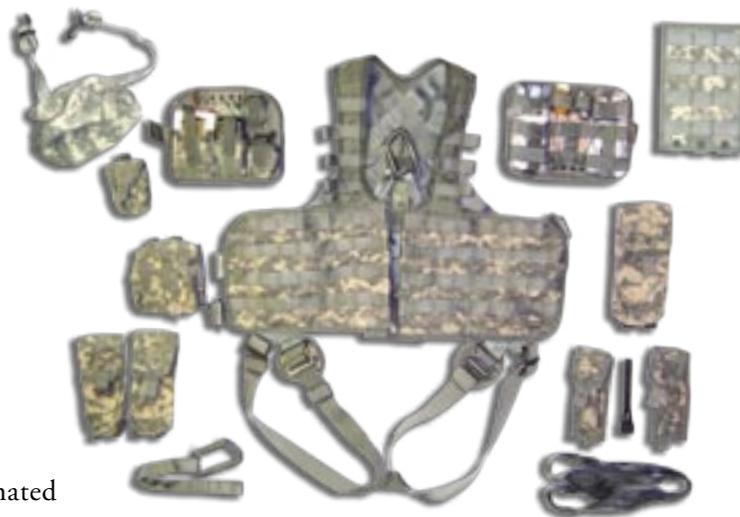
▲ AW GEN 3 SYSTEM

were eliminated to improve durability and repairability and replaced by two inner pockets and a series of MOLLE attachment points. A set of standard pockets are now provided to each crewmember to allow greater tailorability, and a center front zipper is included to increase the overall available storage area at the front of the PSGC for attaching additional pockets. MOLLE attachments were added to the back panel of the PSGC for future growth (e.g., water storage), straps on the center front buckles were redesigned to reduce bulk and increase strap adjustment, the signaling pouch was redesigned to be similar to the first aid platform in order to reduce bulk and improve accessibility, and the back panel was improved to enhance comfort and fit adjustment. The Gen 3 also eliminated the Extended Equipment Pouch, the lower retention and multi-tool straps, and numerous snaps and grommets.

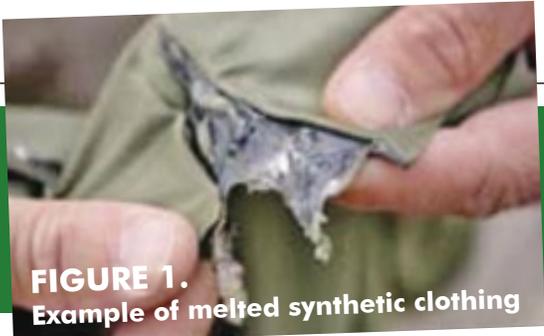
FIGURE 1.
Example of melted synthetic clothing

- **Polyester underclothing manufactured by companies such as Under Armour®, CoolMax®, and Nike®.** Undergarments manufactured from synthetics such as polyester or acrylic can melt and fuse to skin when exposed to high temperatures and flames (figure 1). This warning also applies to novelty undergarments such as underwear with cartoon characters, jokes, etc. Burns from these garments melting against your skin can be disfiguring and even fatal. Military doctors have reported an increased difficulty in burn-related wound treatment from the necessity of removing melted clothing from the wound. Natural fibers such as cotton, wool, or Nomex® are the best materials for aviation undergarment use.

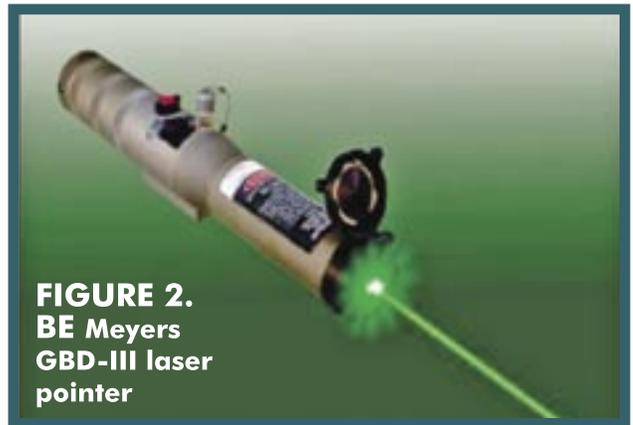
FIGURE 2.
BE Meyers
GBD-III laser
pointer

compromise the safety of the crew during night missions. There are a wide variety of lasers available, ranging from powerful military pointers (figure 2) to lower-powered, presentation-style pointers (figure 3).

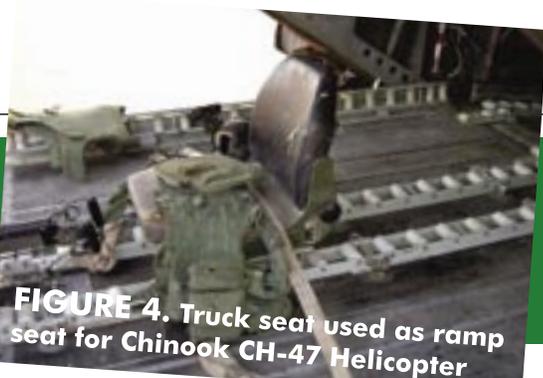
FIGURE 4. Truck seat used as ramp seat for Chinook CH-47 Helicopter

gun mounts on aircraft and using passenger vehicle seats (figure 4) as door gunner and ramp seats. Fabricated gun mounts may not take into consideration appropriate traverse and elevation limits, allowing the operator to inadvertently shoot the rotor blades. Automobile seats are not designed to the same crashworthiness standards of aircraft seats and may pose a real health hazard in a crash. Something as simple as modifying individual flight crew seat cushions could result in serious injury during an emergency.

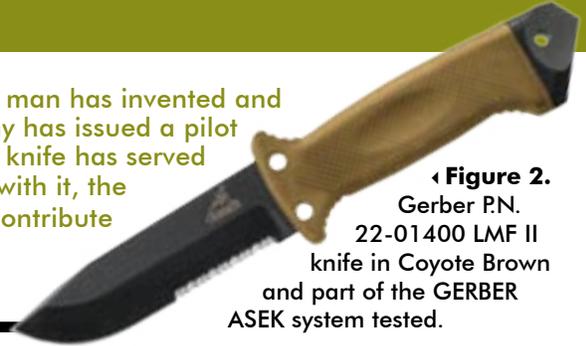
◀ **Figure 2.**
Gerber P.N.
22-01400 LMF II
knife in Coyote Brown
and part of the GERBER
ASEK system tested.

In May 2005, Gerber Legendary Blades entered into a Cooperative Research and Development Agreement (CRDA) with the U.S. Army Aeromedical Research Laboratory (USAARL). The CRDA was to test and evaluate the Gerber LMF II knife (figure 2) against the Army-issue ASEK produced by Ontario Knife Company for the purpose of determining whether the Gerber knife met the same standards as outlined in the ASEK ORD. Testing and evaluation

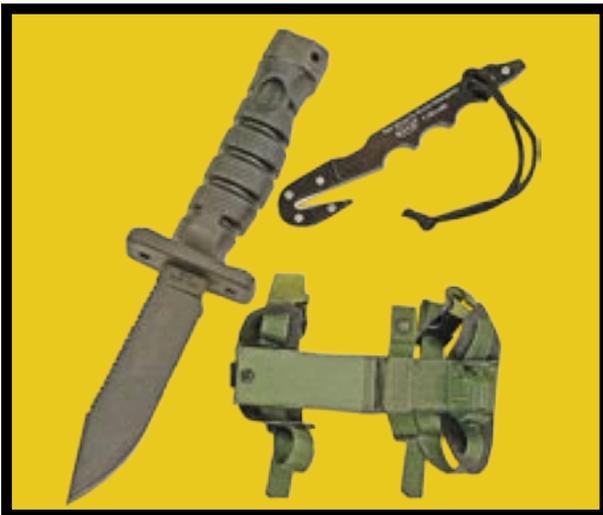
◀ **Figure 1.** Ontario Knife Company part number 1400, NSN 1095-01-518-6832.

After finalizing the list of desired attributes the knife should include, the Army issued an operational requirements document (ORD) for an ASEK in August 2001. A number of companies presented samples, but only the Ontario Knife Company's submission (figure 1) successfully met the requirements of the ORD. As a result, an NSN was assigned to Ontario Knife Company, and funds were procured for approximately 25,000 ASEKs for direct issue to Army Aviation units. Between June 2004 and May 2005, 11,881 Army ASEKs were purchased by Defense Supply Center–Columbus, OH, and the knife has been making its way onto aviation life support equipment (ALSE) vests ever since.

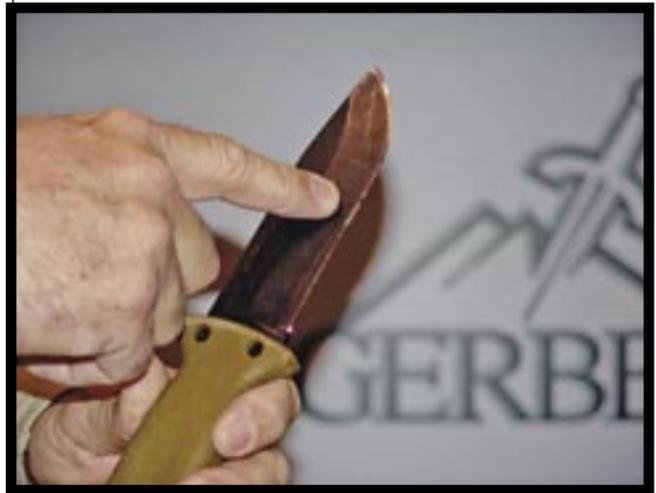
▲ **Figure 3.** Gerber Legendary Blades LMF II with finger pointing to burns in blade just above serrations.

SFC Johnson and his spotter were able to return home and share this story. The only damage to the knife was some slight blade edge burns (figures 3 and 4). It should be noted cutting charged electrical wires is potentially fatal and should not be attempted. As SFC Johnson stated, "I wasn't exactly thrilled about having to cut hot lines, but in battle, you do what you have to do."

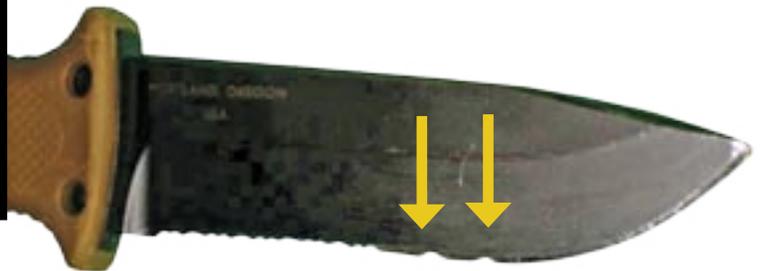
▼ **Figure 4.** Arrows pointing to areas where charged electrical cables burned the blade.

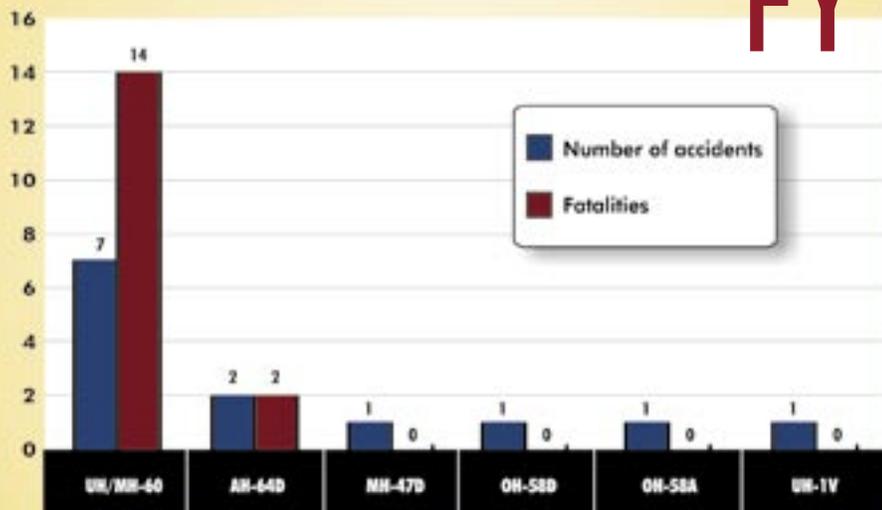
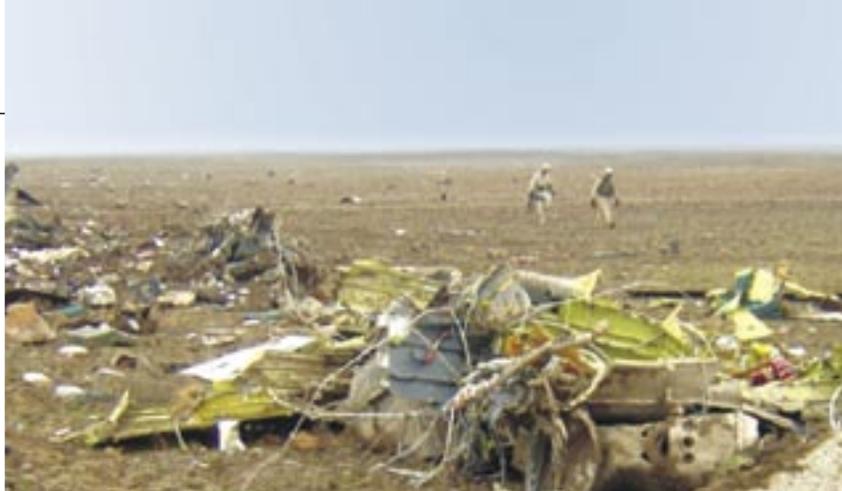
CLASS A AVIATION ACCIDENTS

During First Half of **FY 2006**

It's time for us to take a look at how we're doing as an Army regarding aviation accidents thus far in Fiscal Year 2006 (FY06). Army Aviation experienced 13 Class A accidents the first half of FY06, a decrease from last year's 17. There were 12 Soldiers and 4 civilians killed in these accidents, which cost over \$59 million. Over two-thirds of the accidents (9) occurred in the Central Command (CENTCOM) area of operations (AO). The chart on page 19 compares the number of accidents and fatalities for each aircraft type involved.
