TF MULESKINNER MAINTENANCE SAFETY ALERT #2

TF MULESKINNER SAFETY
AFGHANISTAN 12-15

Damage noted is not all-inclusive

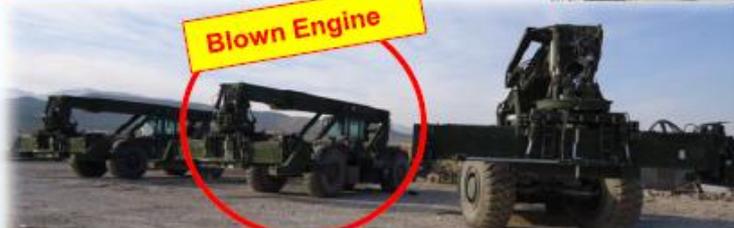
Blown Engine

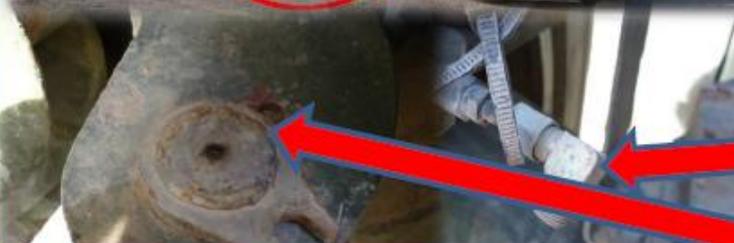
Auto Lube Line Disconnected
and Grease Fitting Installed on
Some, Bolts Sheared and Other
Damaged Parts

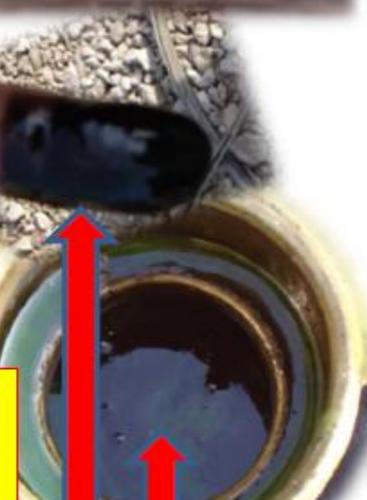
Anti-freeze all inside cab. Would only run 20 minutes at a time and then Radiator Hose would blow off. The hose would be put back on and it would run until the hose blew off again; no Anti-freeze was added, this was done until it wouldn't run any more

So Much Oil in Radiator;
Almost Turned to Grease
