# ELECTRICAL HAZARDS

## VEHICLES

**Low-hanging overhead electrical power lines has caused electrical shocks to personnel, and severe damage to vehicles and vehicle equipment.**

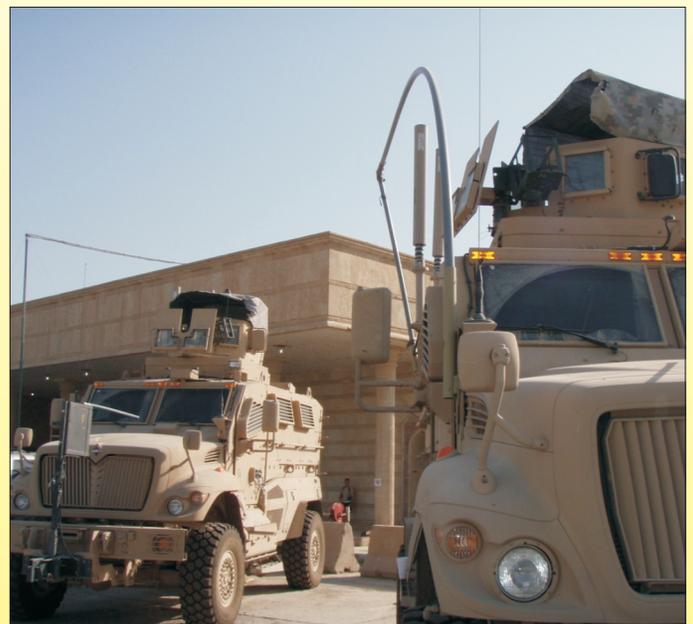
- Low-hanging overhead electrical power lines
- Height of new equipment (e.g., STRYKER and MRAP)
- Radio antenna improperly tied down
- Gunner/TC not positioned at nametag defilade and gunner's weapon muzzle positioned high

- Secure antenna when tactically feasible
- Gunner/TC maintain nametag defilade
- Coordinate with LARS to develop effective wire-strike prevention devices for tactical vehicles

- During PCIs ensure equipment on top of vehicles is properly secured
- Commanders, leaders conduct walk-around spot inspections
- Leaders ensure Soldiers maintain nametag defilade and weapons situational awareness
- Soldiers enforce corrective measures to prevent electrical hazards
