# Flightfax

ARMY AVIATION  
RISK-MANAGEMENT  
INFORMATION

MAY 2005 + VOL 33 + NO 5

## POWER MANAGEMENT...

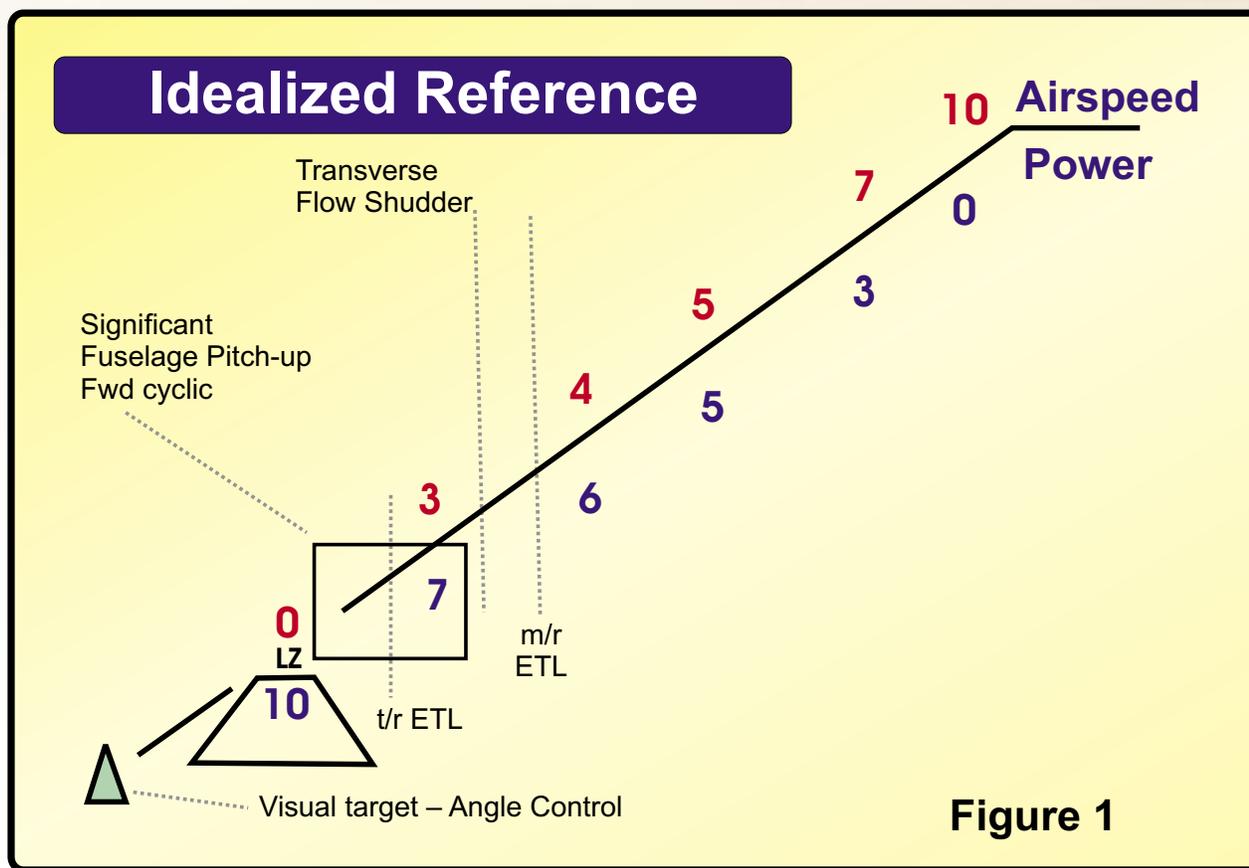
**Figure 1**

of the speed at which interception occurs. The references to loss of main and tail rotor effective translational lift, transverse flow shudder, and pitch-up of the fuselage are intended to acknowledge aerodynamic events that will occur during the approach for which anticipation and compensation by the pilot is required to maintain angle and heading. If executing to a pinnacle or ridge (as depicted in Fig. 1) using a rifle sight to maintain the angle, under or over arcing is detected instantaneously. However regardless of the type of approach, at detection of under or over arcing, the pilot should note airspeed, power, and *distance remaining*—one or both of speed and power is incorrect for the

distance remaining. Subsequent approaches will determine what the correct combination should be. *The most important external visual reference to be refined in this approach (or any other) is the distance remaining to termination.* This is particularly critical as so many of our operational environments have missing or offer

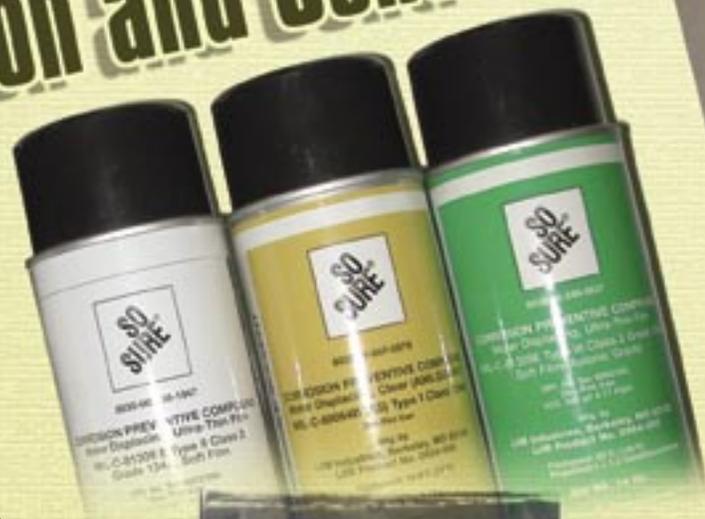
Bad Preservation

Keeping the aircraft and equipment clean is a vital step. Scheduled aircraft washes remove sand, grime, and other contaminants. When the aircraft are washed it is very important to ensure all the soap is rinsed away. Dried soap can be very damaging to protective paint systems. The moisture in the air and overnight dew will reactivate the soap which begins to attack the paint, softening it and exposing the base metal. Performing detailed corrosion inspections to identify

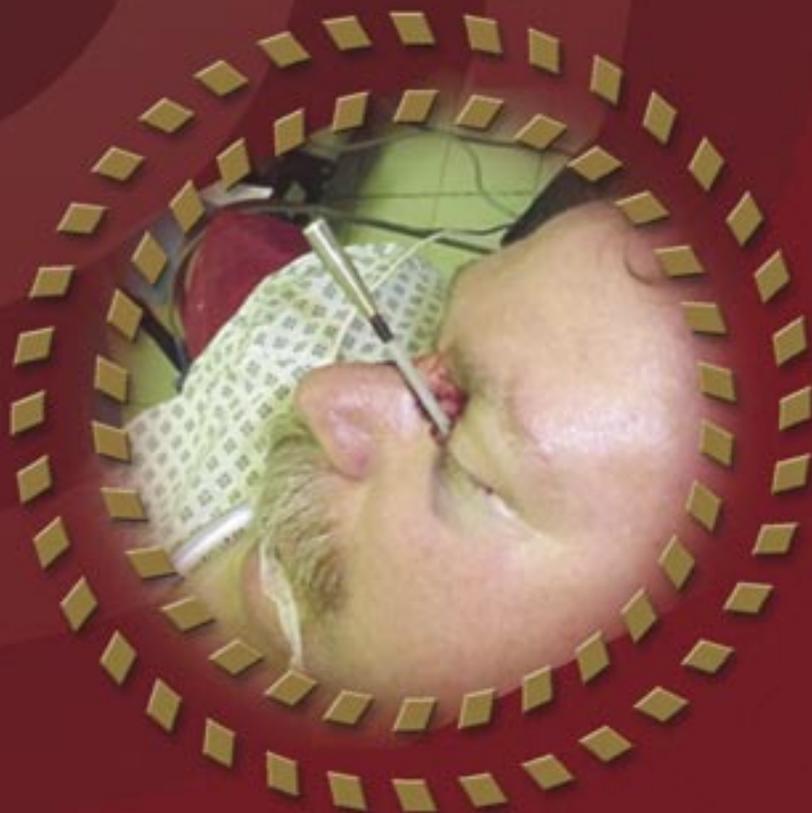
The plane had been taxied to the ramp where the wings overhung the taxiway. While preflighting the aircraft the FO had to walk into a ditch, and as he was coming back up he walked into the wing. The static wick (on Citation jets, they're a solid, straight metal-type) penetrated his eye socket 3-1/4 inches, but luckily broke off the aircraft before going any further. When they X-rayed his skull, the wick was found to be only 1/4-inch from his brain. They extracted the static wick with no damage to the eye itself. The lesson learned is: Don't allow yourself to be distracted around aircraft.

Note: These pictures were posted by the pilot on his company's Web site in hopes of helping to prevent another accident.
